Seal Beach WAVE

Water Service Upgrade Enhances Reliability for Local Homes

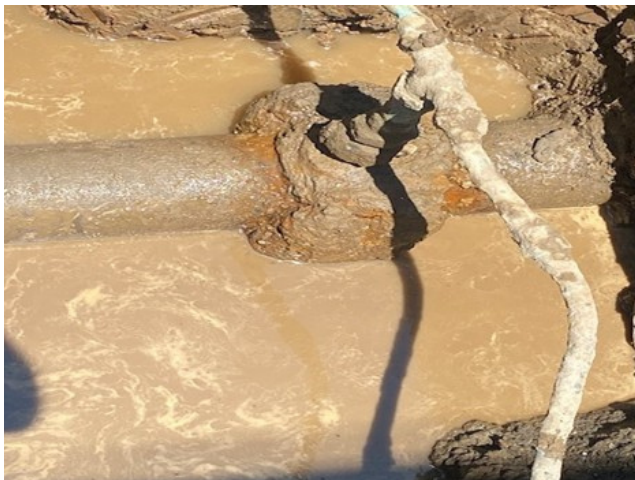
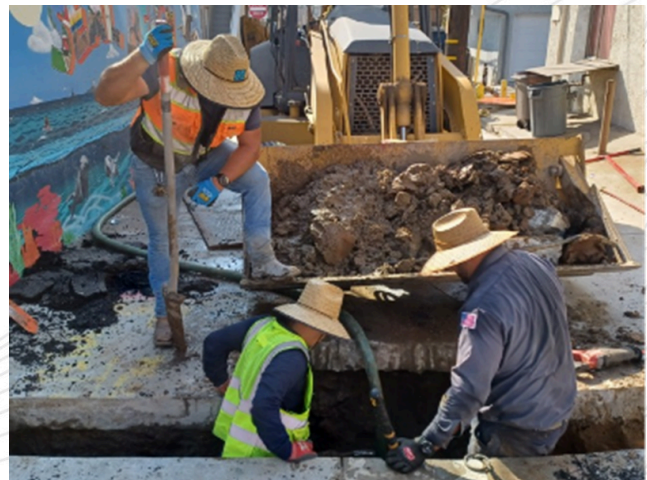
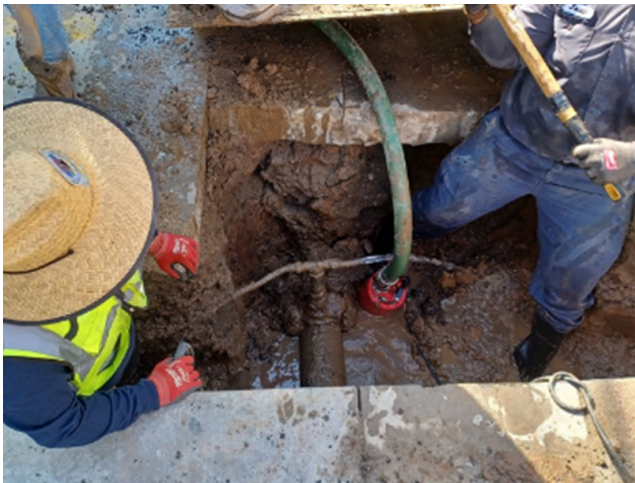
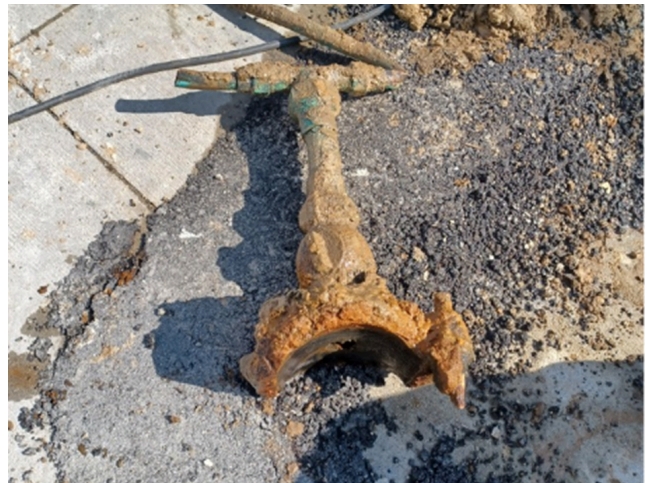
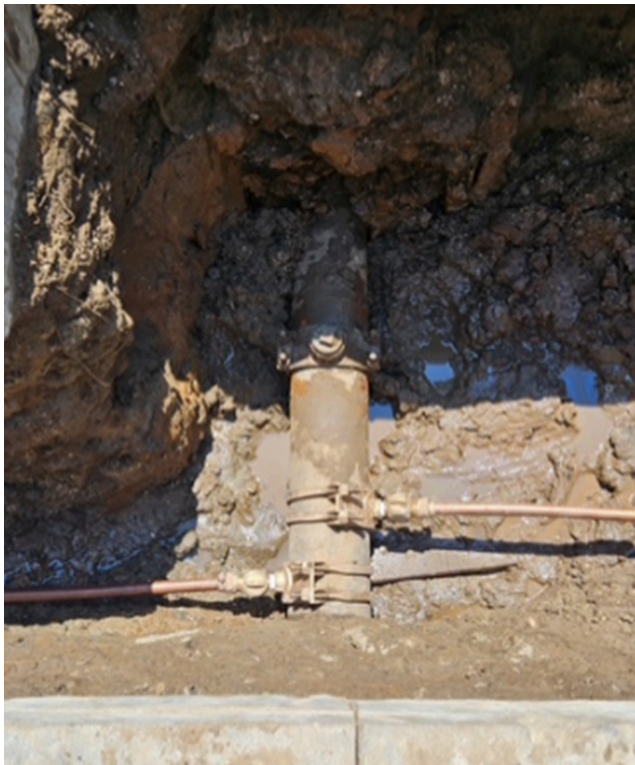
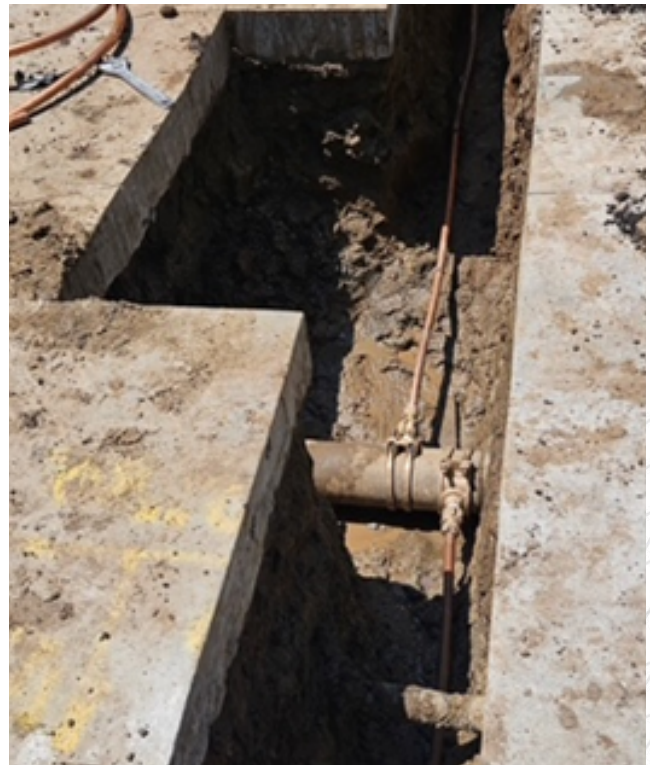
During a routine inspection, our Utilities crew found a residential $\frac{5}{8}$ -inch water meter that needed replacement—and because it sat outside the City's right-of-way, it had to be relocated. When crews excavated the main line, they discovered an unconventional setup of a single $1\frac{1}{2}$ -inch service fitting that supplied two homes from one tap source. This was a decades-old connection that was badly corroded and leaking.

To repair the issue, the water operators:

1. **Removed and capped the faulty service fitting** to stop the leak.
2. **Tapped two (2) brand-new 1-inch service lines** from the main.
3. **Installed new meters and protective boxes** in the correct right-of-way location.
