**Report Presented to the City of Seal Beach**

**Facility Condition Assessment Study  
and Strategic Planning Project**

**Facility Condition Assessment  
Final Draft Report**

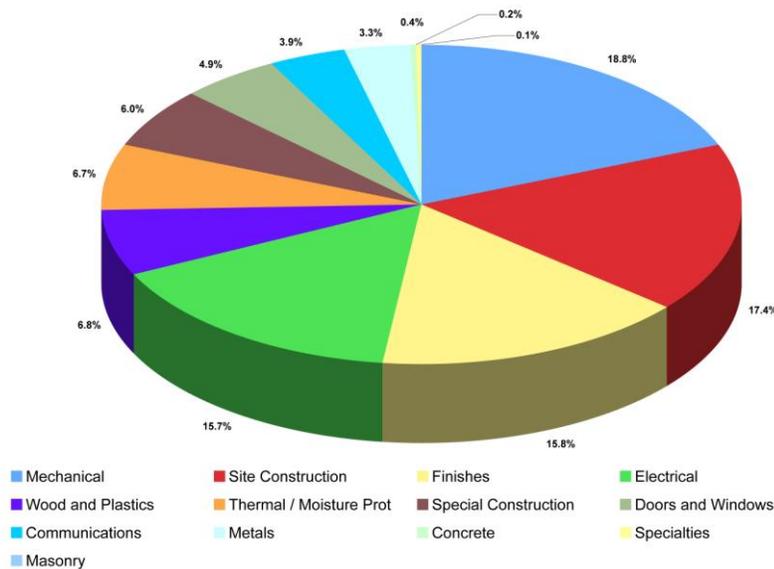
**Exhibit  
Total Renovation Costs by Component**

System Component	Direct Cost	Percent
Mechanical	\$3,415,200	18.8%
Site Construction	\$3,159,600	17.4%
Finishes	\$2,870,600	15.8%
Electrical	\$2,861,200	15.7%
Wood and Plastics	\$1,244,000	6.8%
Thermal / Moisture Prot	\$1,210,800	6.6%
Special Construction	\$1,094,000	6.0%
Doors and Windows	\$890,100	4.9%
Communications	\$706,000	3.9%
Metals	\$597,500	3.3%
Concrete	\$70,400	0.4%
Specialties	\$33,800	0.2%
Masonry	\$21,000	0.1%

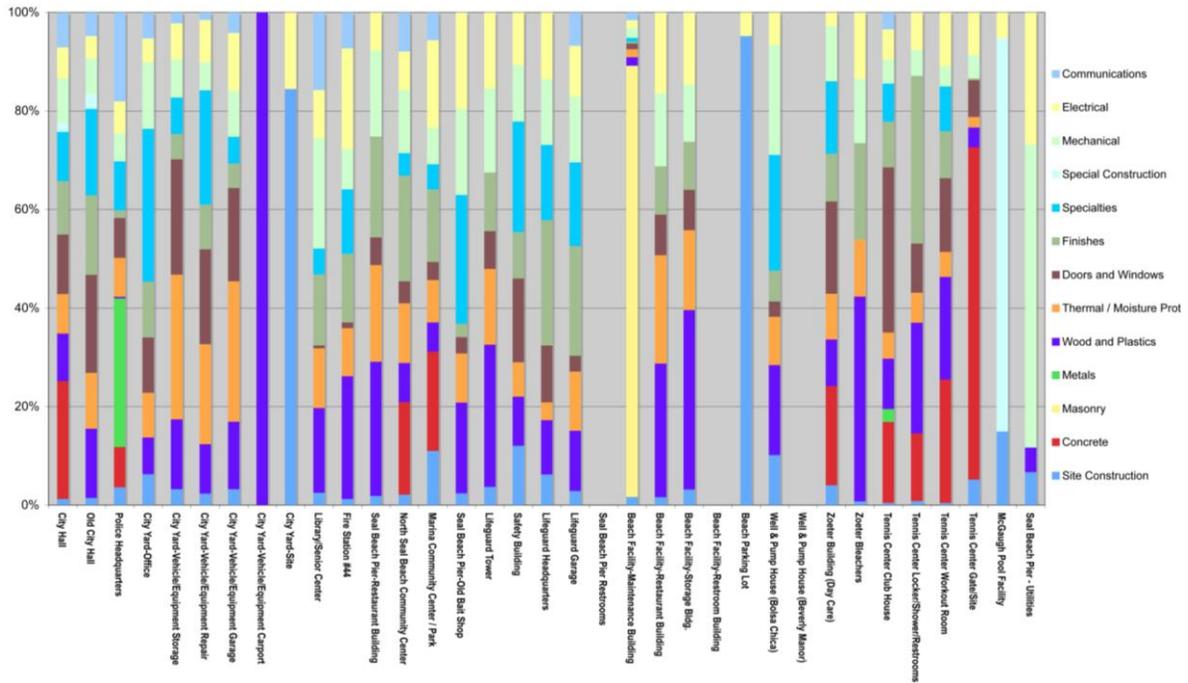
## Renovation Costs by System Component by Facility

The following chart illustrates the conceptual estimates of probable renovation costs as distributed into various construction component parts by facility. This chart further illustrates the variety of construction issues associated with facilities of wide construction type, disperse missions, and integrated remedy requirements. The diversity is clear in the chart, and underscores another reason for presenting these renovations as holistic building requirements, and it further shows limitations in FCI comparisons. Note that three properties are currently in the process of renovation, and are not graphed: Seal Beach Pier Restrooms, Beach Facility Restroom Building, and Beverly Manor Well and Pump House.

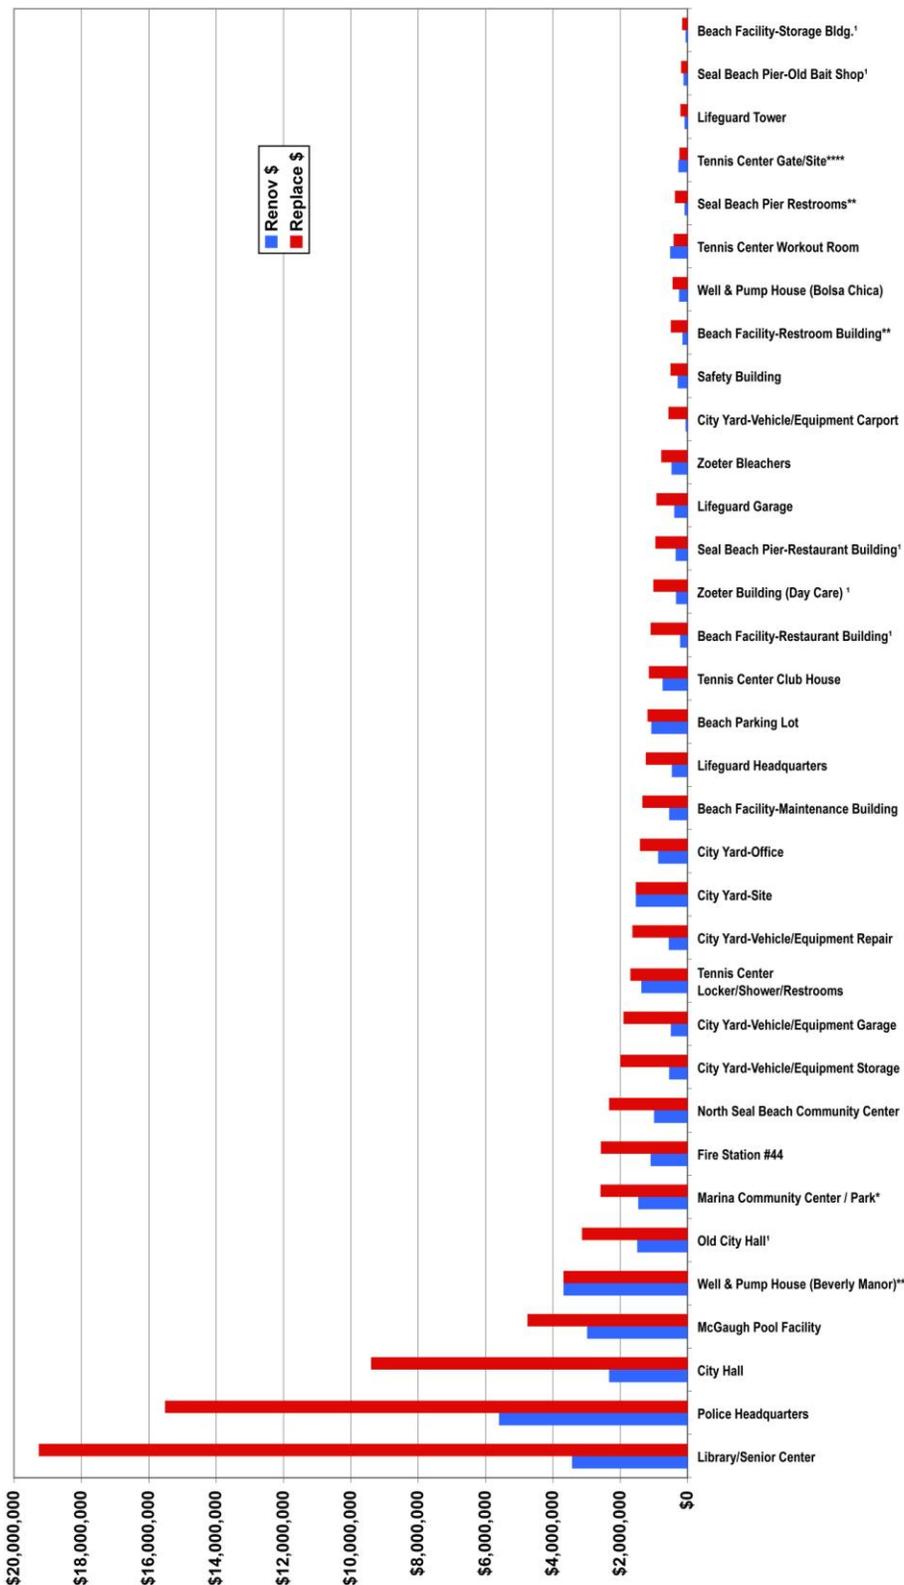
**Exhibit  
Total Replacement Cost vs. Renovation Cost**

The following table and associated chart summarizes the conceptual estimates of probable replacement vs. renovation costs as computed for this report, and presented with the facility surveys and assessment packages appearing below in Section 5.

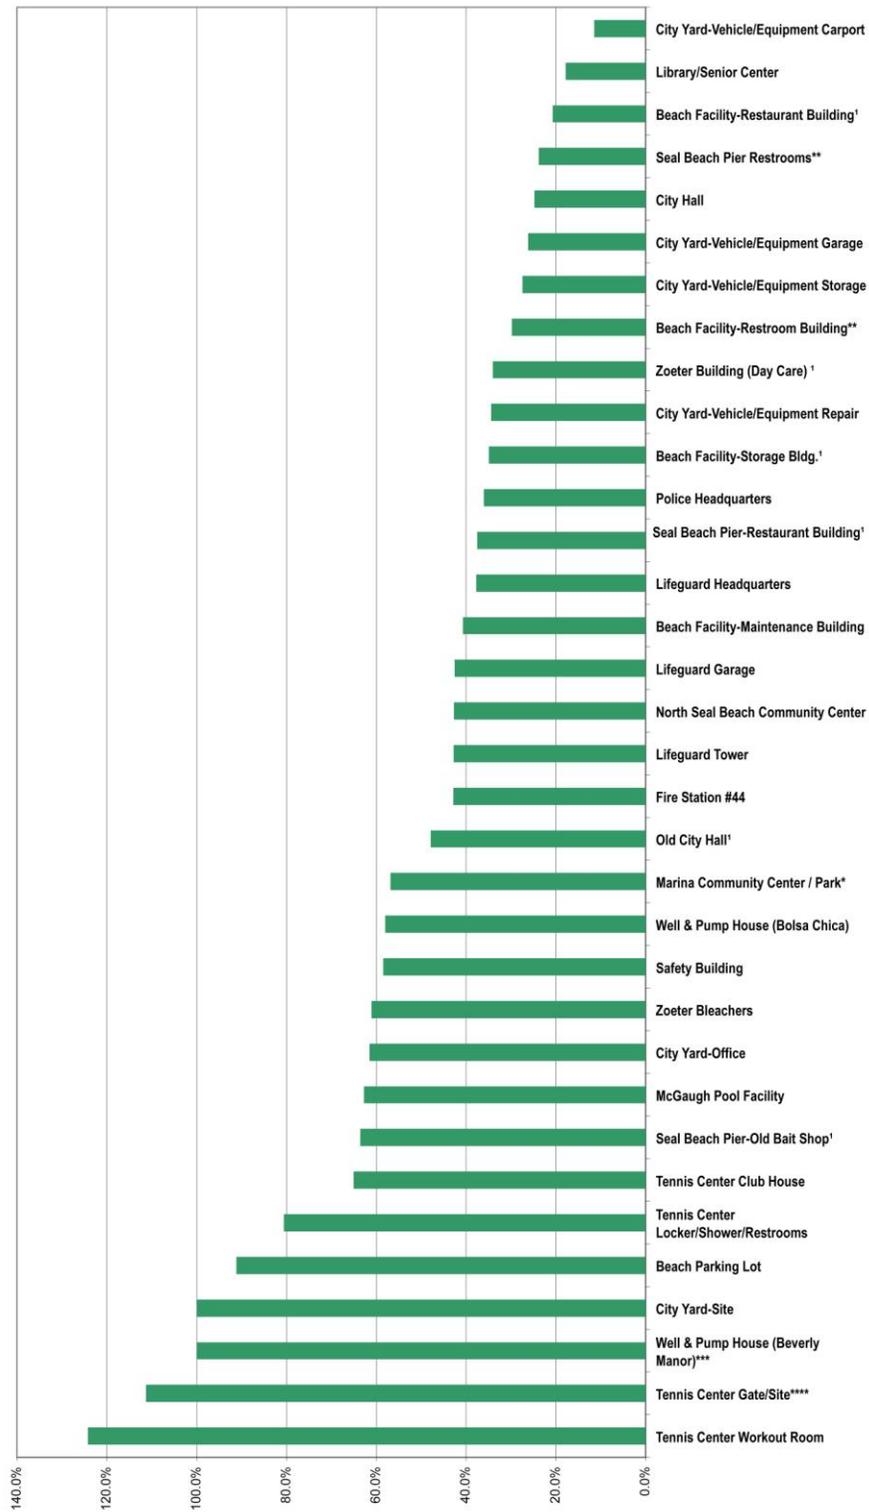
**Exhibit  
Graph of FCI by Facility Surveyed**

The following table summarizes the FCI computed for each of the facilities surveyed. This index is based on the ratio of the conceptual estimates of probable replacement and renovation costs as presented above. Note assumptions, qualifications, and notes for each entry as presented elsewhere in this report. Note that the values range from 11% to over 100%. FCI's over 100% occur because the specific facility conditions, requirements, and constraints of the existing facility require more expense to remedy the significant issues than is computed by a hypothetical construction of a replacement facility of similar size and design, assuming a clean and prepared site on which to provide it.

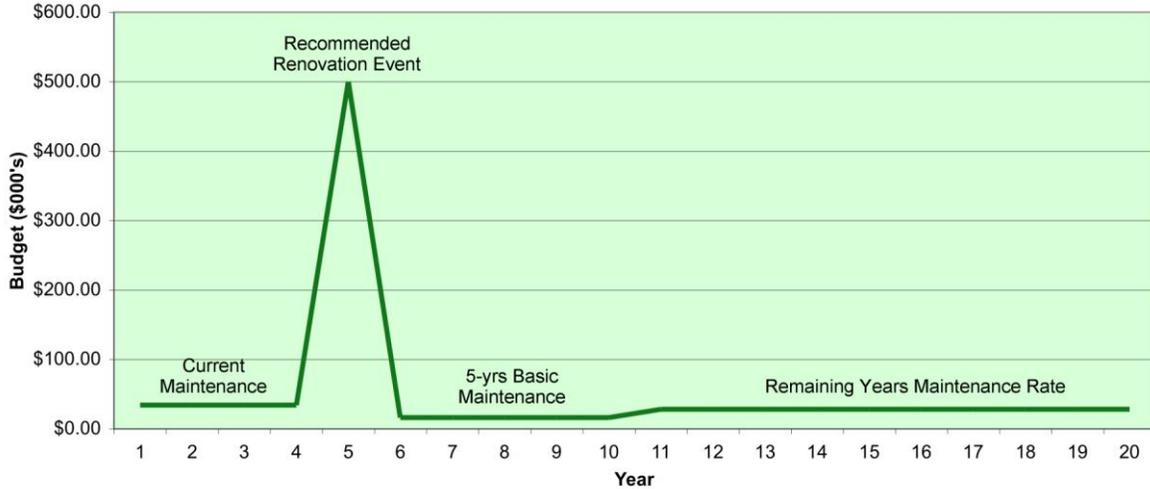
The 20-year plan is based on assembly of the proposed renovation costs and the maintenance costs noted above. On a building-by-building basis is conceptually shown as follows. Note that this concept sketch shows the renovation in the 5th year, but the year changes with each facility.

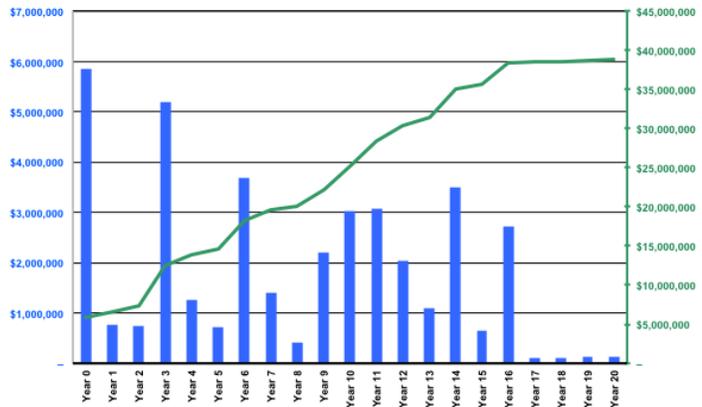
**Exhibit  
20-Year Master Plan Summary  
of All Costs as Described**

This approach has been applied to the facilities listed in the above tiers, and is tabulated in the following worksheet. In summary, the annual expense plan per year is shown in the following exhibit. In the associated chart, the green line and numbers refer to the cumulated total, and the blue bars and numbers refer to the annual figures.

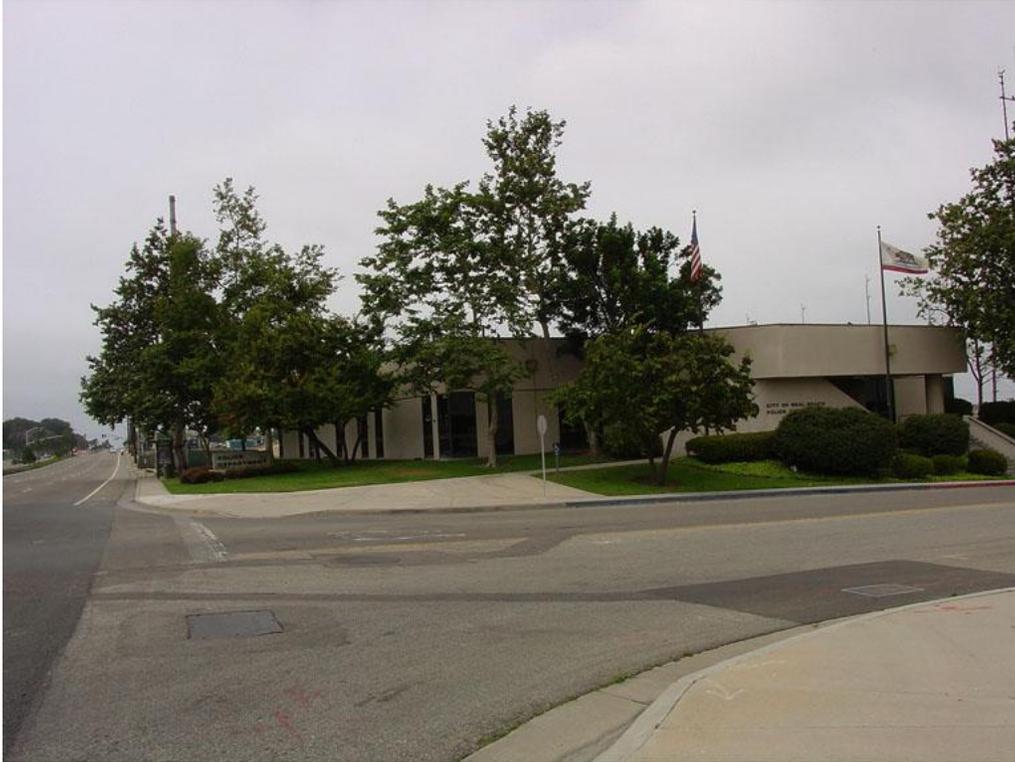
### POLICE HEADQUARTERS

911 Seal Beach Boulevard  
Assessment date: October 14, 2010

The City of Seal Beach Police Headquarters was built in 1978 and has had several modifications and additions since. The most recent renovation was done in 2009 / 2010. This latest scope of work included minor site work; new exterior lockers; renovation to the lower level evidence storage room, lockers, showers and restrooms; and renovation to the upper level restrooms; Chiefs restroom; storage room and kitchen / balcony. Previous renovations included the addition of the communications center, renovation of the security "Sally Port" to administrative office area, upgrades to the upper level multi-purpose room including provisions for an Emergency Operations Center (EOC), new emergency generator and associated electrical renovations, general overall interior finish upgrades and miscellaneous revisions to the detention facility.

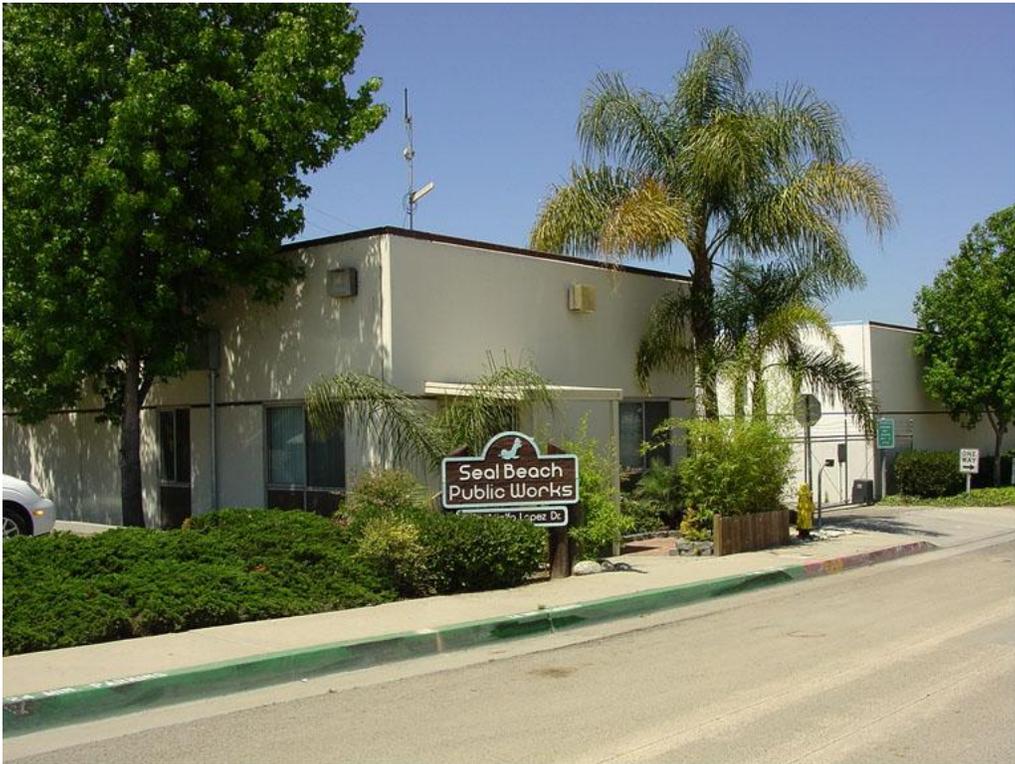
## Building #4

### CITY YARD – ADMINISTRATION BUILDING

1776 Adolfo Lopez Drive  
Assessment date: September 30, 2010

The City Yard complex with the adjacent Police Headquarters was originally constructed in 1978. The City yard complex includes a main administration building with three separate vehicular and general storage shop buildings, a large canopy carport structure and associated site storage areas. The facility is accessed via two secured entries off of Adolfo Lopez Drive.

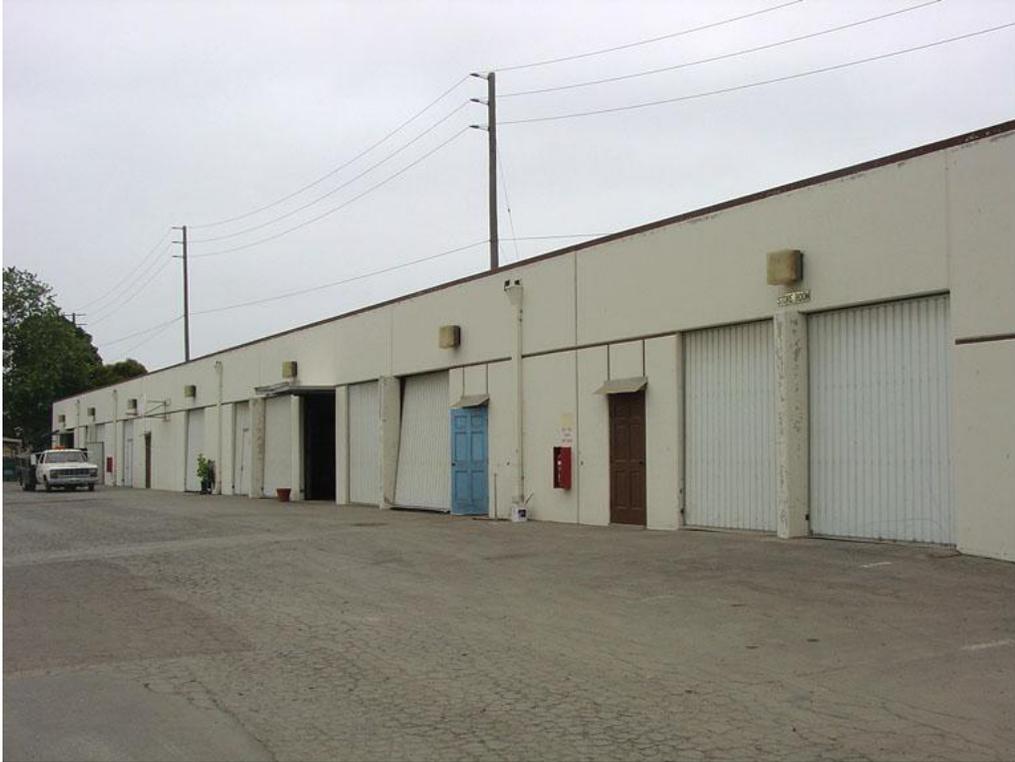
## Building #4A

### CITY YARD – VEHICLE / EQUIPMENT STORAGE (SOUTH SIDE SHOPS)

1776 Adolfo Lopez Drive  
Assessment date: September 30, 2010

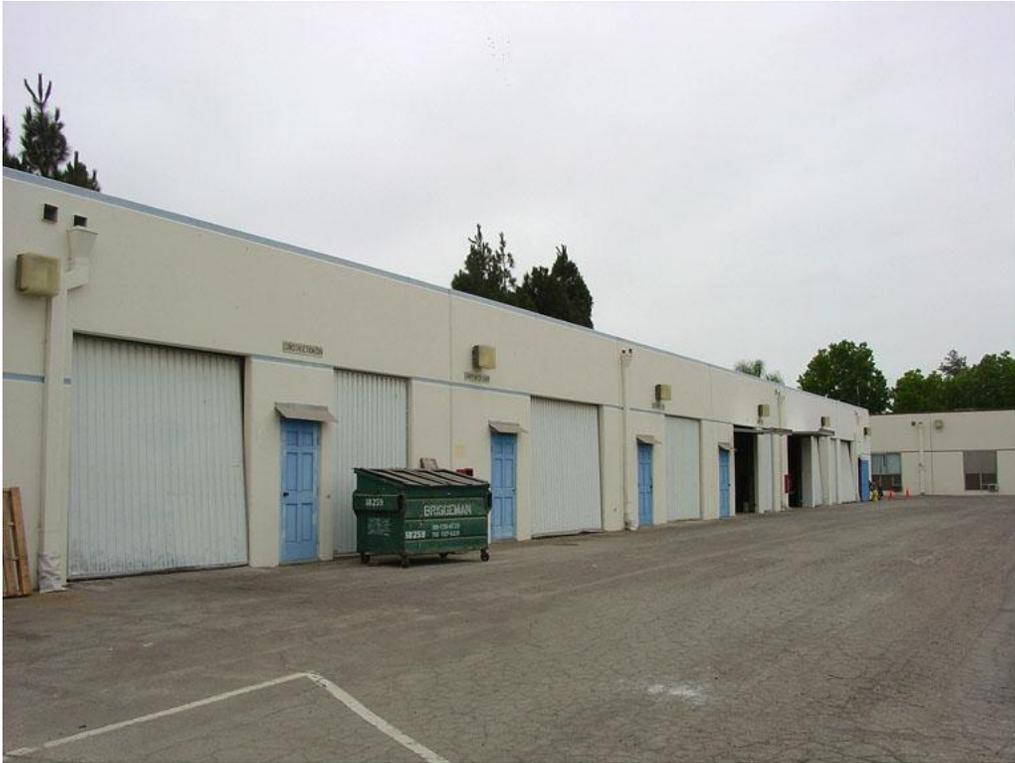
## Building #4B

### CITY YARD – VEHICLE / EQUIPMENT STORAGE (NORTH SIDE SHOPS)

1776 Adolfo Lopez Drive  
Assessment date: September 30, 2010

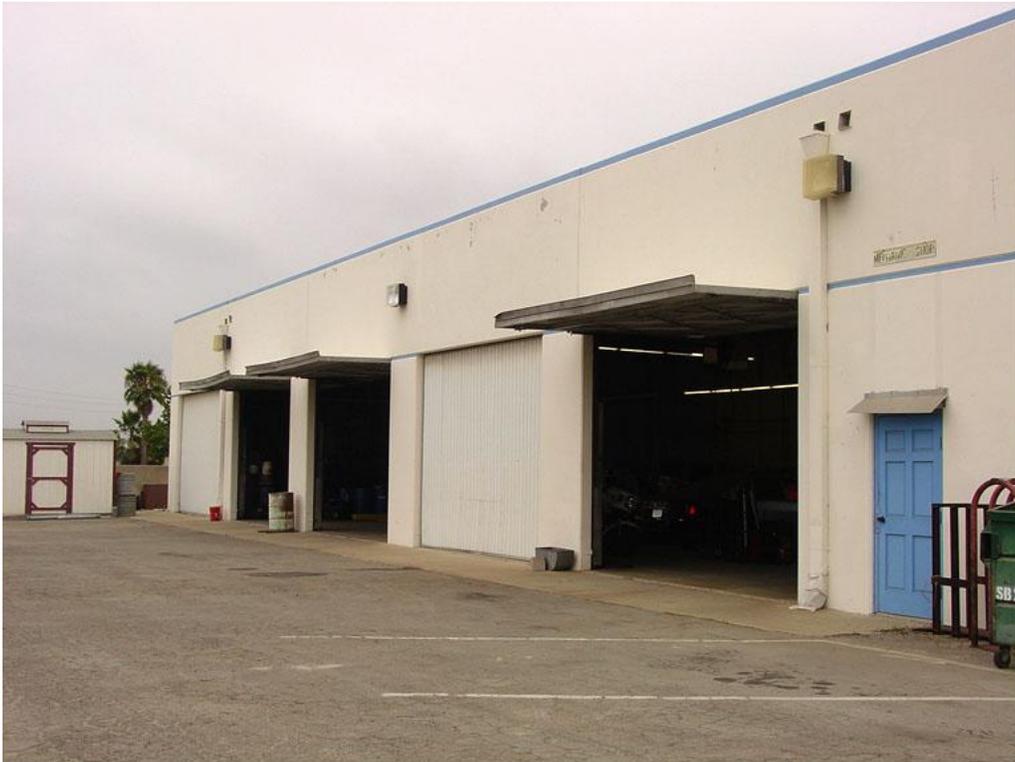
## Building #4C

### CITY YARD – VEHICLE / EQUIPMENT REPAIR (GARAGE)

1776 Adolfo Lopez Drive  
Assessment date: September 30, 2010

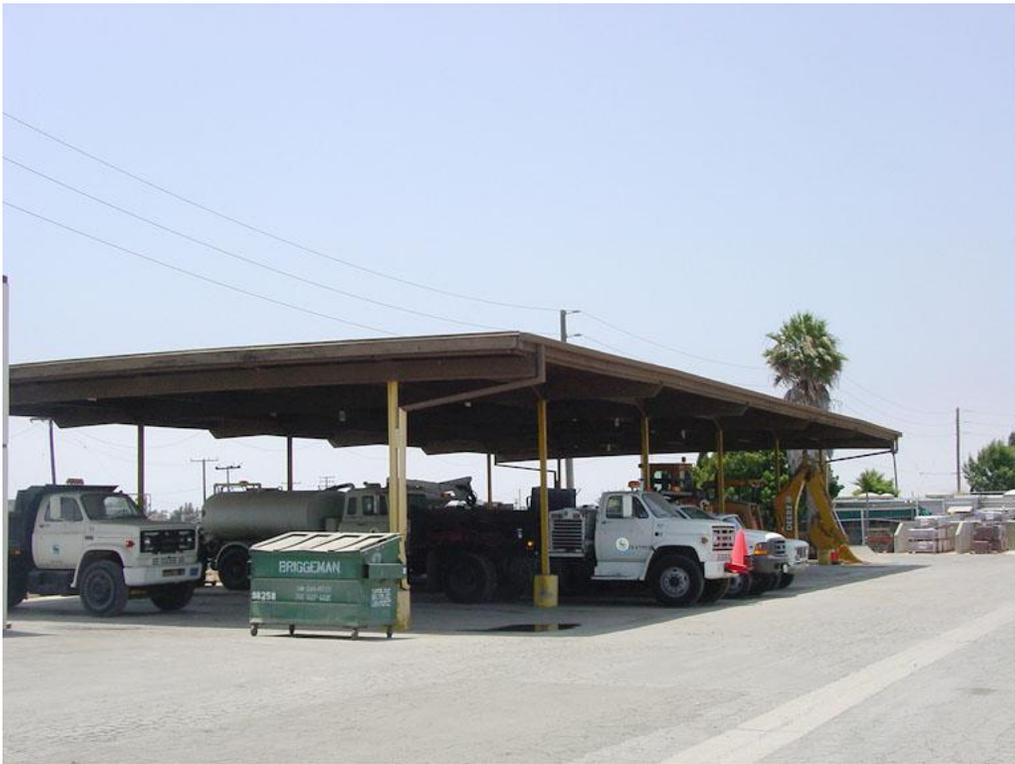
## Building #4D

### CITY YARD – VEHICLE / EQUIPMENT STORAGE (CARPORT)

1776 Adolfo Lopez Drive  
Assessment date: September 30, 2010

This canopy structure has a flat low-sloping wood-framed roof supported on steel posts. The structure is in reasonable condition for its age. No deterioration was observed during the assessment.

In order to provide a useful remaining life of at least 20 years, we recommend that the structure be further evaluated seismically. A more positive lateral system could be introduced for a modest cost, if the existing level of seismic risk is not acceptable.

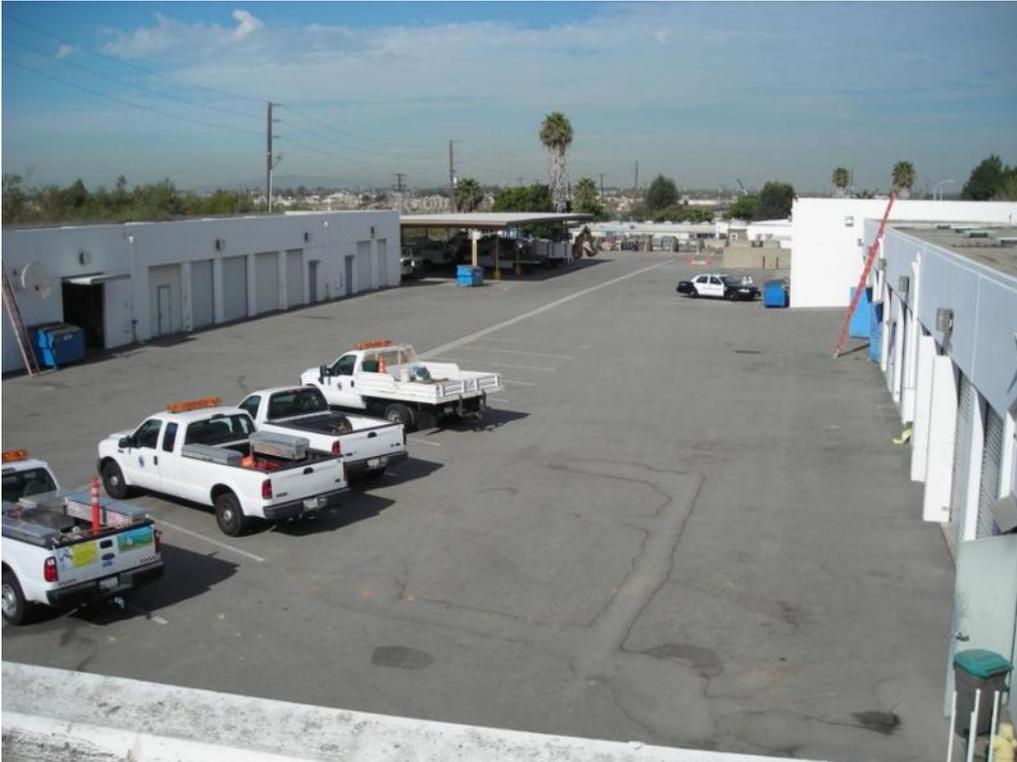
## Building #4 - Site

### CITY YARD – SITE

The City Yard Site has been divided into pieces and included as separate elements in greater detail among the reports for Buildings 4, 4A, 4B, 4C, and 4D. See the noted reports for details of deficiencies.

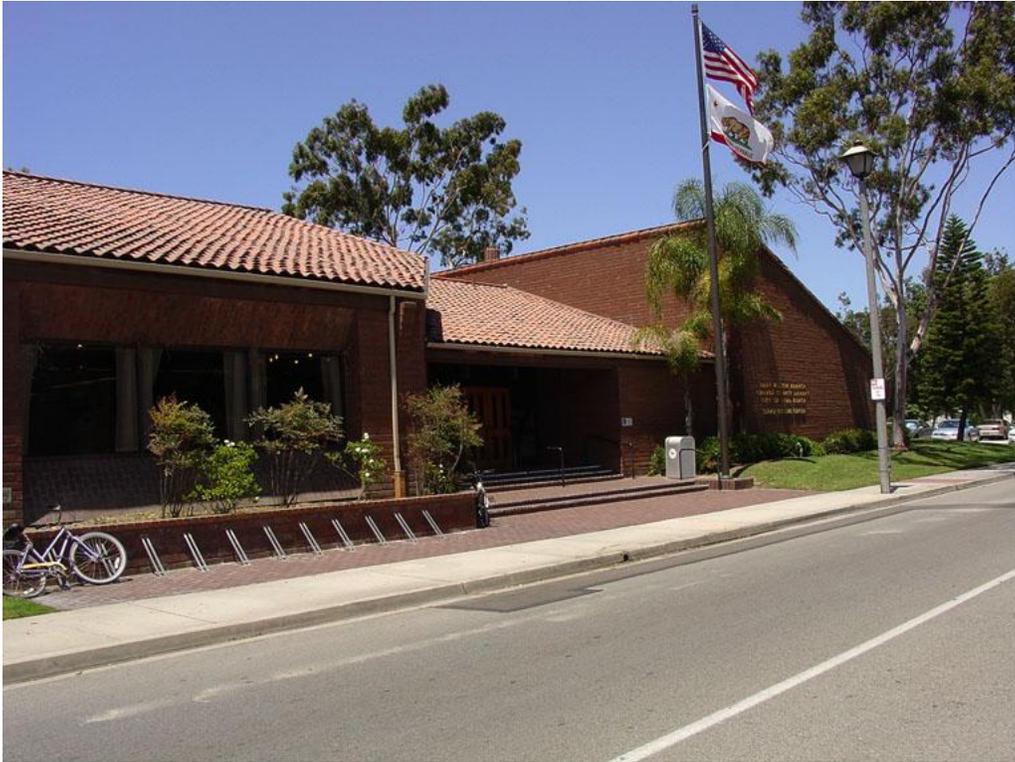
## Building #5

### LIBRARY / SENIOR CENTER (MARY WILSON LIBRARY)

707 Electric Avenue  
Assessment date: October 7, 2010

The Library / Senior Center is a single joint-use building originally constructed in 1976. It does not appear to have been significantly altered since originally constructed with the exception of improvements to the entry doors and minor modifications in the Senior Center. The facility is approximately 28,286 square feet and consists of a through building entry lobby with access to both north and south bound Electric Avenue with common restrooms; to the south of the lobby is the entry to a multi-purpose library room with circulation desk and office / workroom area; to the north of the lobby are a janitor room, electrical room, an office (book shop) and a multi-purpose senior (community) room. The senior room has a kitchen; storage rooms and access to a private exterior patio.

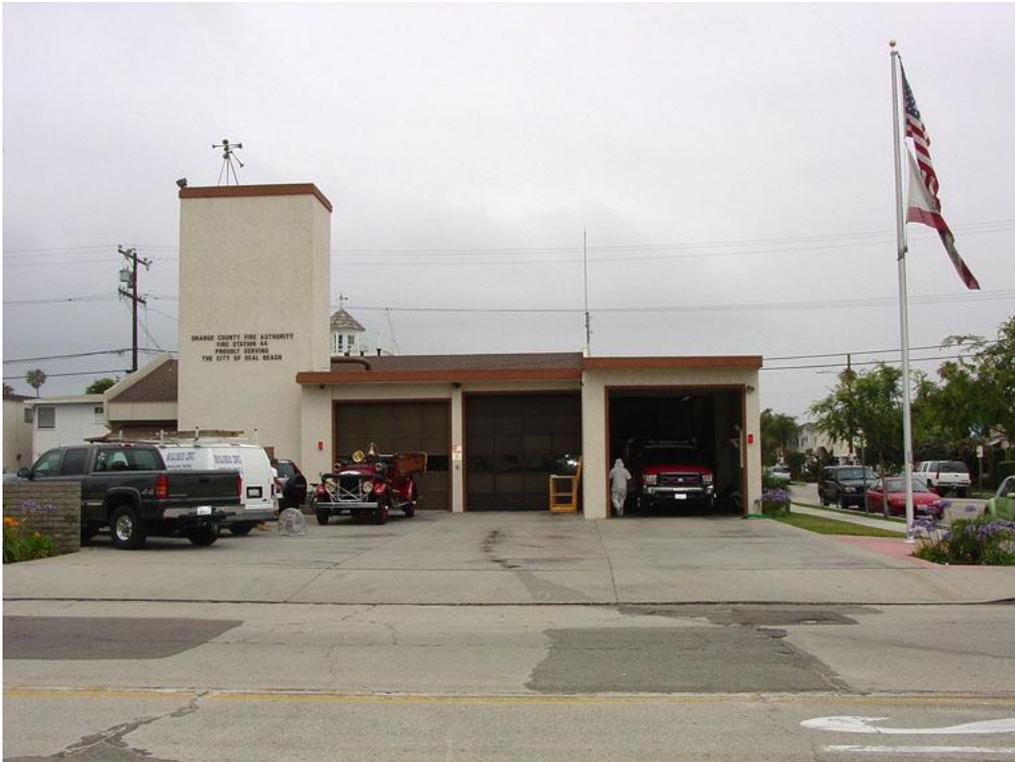
## Building #6

### FIRE STATION #44 (OLD TOWN)

718 Central Avenue  
Assessment date: August 26, 2010

Fire Station #44 was originally constructed in 1960. It has been significantly altered several times since. The original fire station was approximately 1,950 square feet with one large equipment room for the fire engines. The building was enlarged in 1972 by approximately 1,000 square feet. The equipment room was expanded to create three new equipment bays. The remaining equipment room was converted into a multi-purpose room. The original dormitories were not significantly altered. The original office became the captain's dormitory. A new office was built. After the 1972 expansion another expansion extended the north truck bay and added the hose tower. The current facility is approximately 3,500 square feet, one-story exterior cement plaster over wood framed building with sloping and flat roofs.

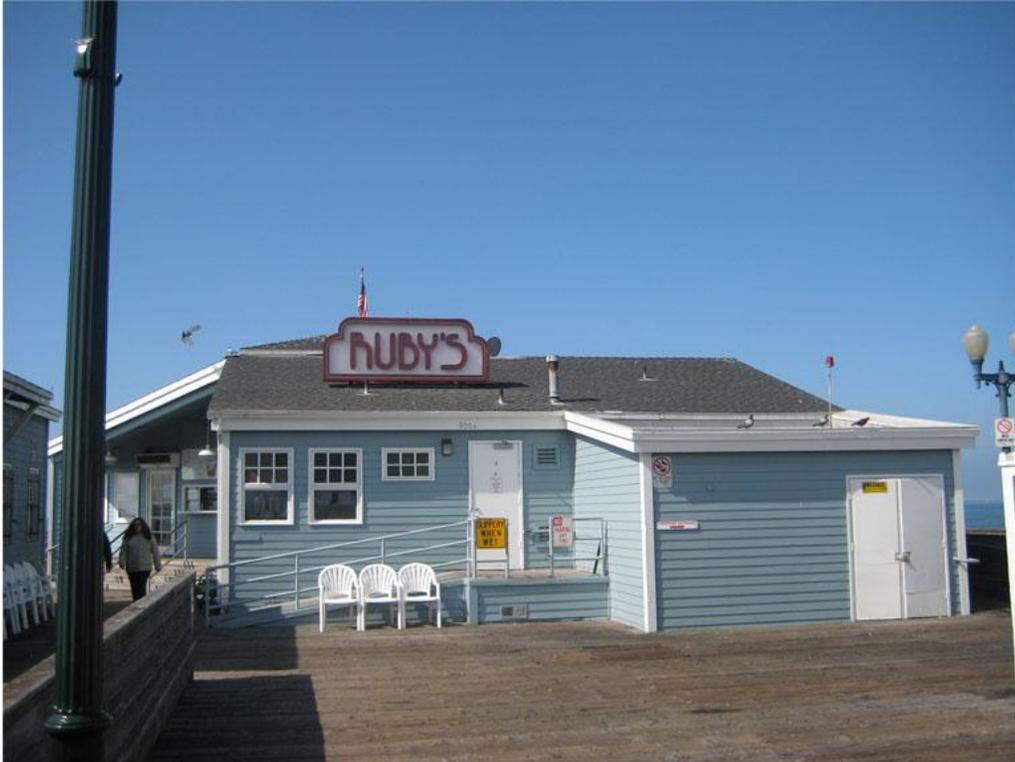
# SEAL BEACH PIER – RESTAURANT BUILDING (RUBY'S)

900A Ocean Avenue  
Assessment date: October 21, 2010

The current restaurant building was constructed in 1985. The building is a single level wood framed structure of approximately 2,679 square feet. The building is currently under lease to a restaurant vender (Ruby's) and the conditions of the lease require the tenant to provide for on-going maintenance.

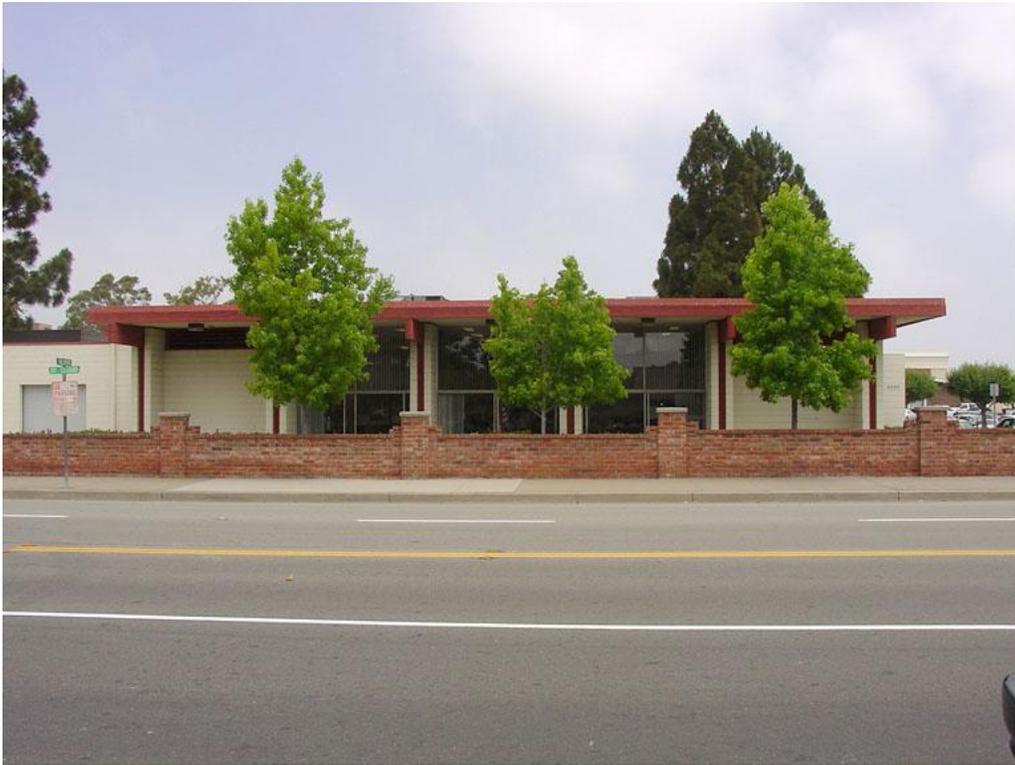
# NORTH SEAL BEACH COMMUNITY CENTER

3333 St. Cloud Drive  
Assessment date: September 23, 2010

The North Seal Beach Community Center was originally constructed in 1968. It has had several renovations and additions over the years. The facility is approximately 4,600 square feet and consists of an entry foyer; a large multi-purpose room; kitchen; restrooms; miscellaneous storage rooms and office. A large storage area accessed from the exterior was added to the rear of the facility. The facility is located adjacent to the Los Alamitos Rossmoor Library and shares common parking.

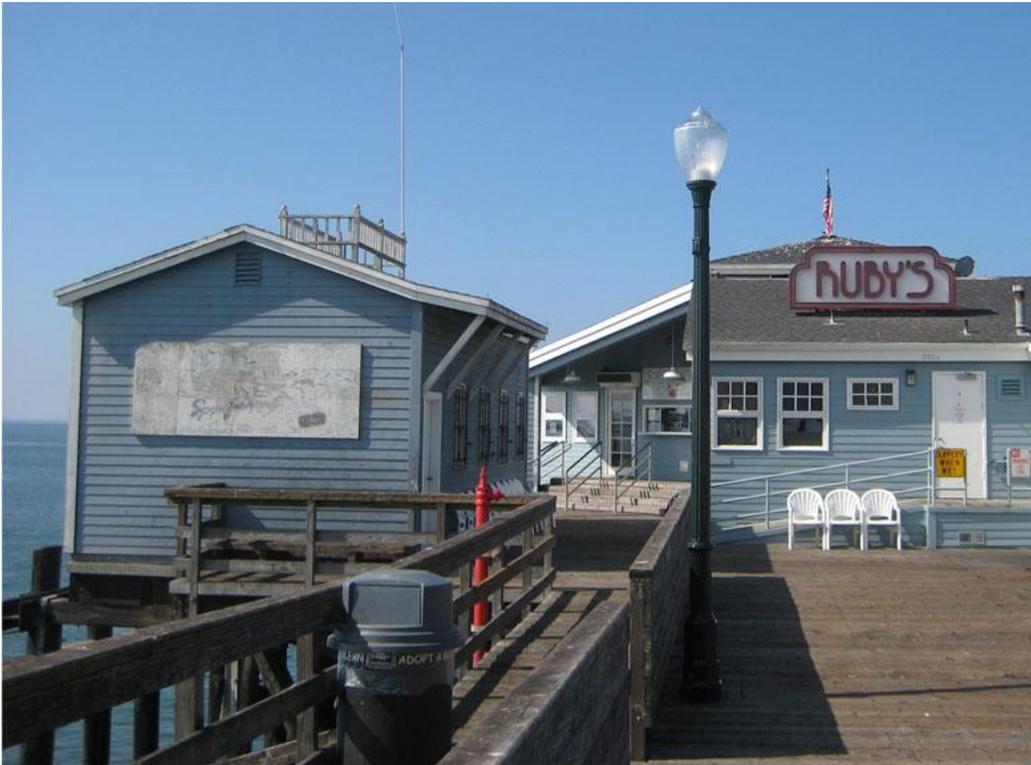
### SEAL BEACH PIER – OLD BAIT SHOP

The current Old Bait Shop building was completely renovated in 1985 as part of the restaurant building. The building is a single level wood framed structure of approximately 510 square feet. The building is currently under lease to a restaurant vender (Ruby's) and the conditions of the lease require the tenant to provide for on-going maintenance.

The overall structure of the building is in relatively good condition. Given the age of the facility and the type of construction a structural analysis should be performed to determine if any structural upgrades would be required. It should also be noted that this building is located in an ocean marine environment.

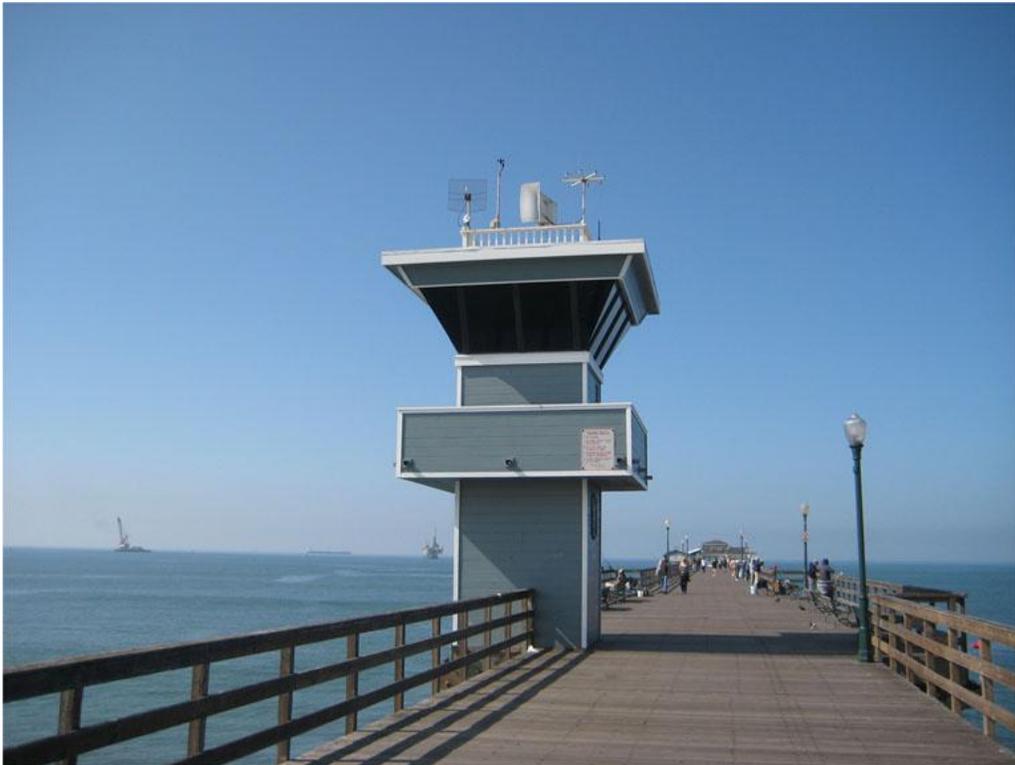
## SEAL BEACH PIER – LIFE GUARD TOWER

The Life Guard Tower was damaged in the fire and rebuilt in 1993 and has basically gone unchanged since. The building is a multi level wood framed structure of approximately 516 square feet. The building has a main access level from the pier, a mid-level communications room with exterior perimeter catwalk and an upper level observation level. Access to the upper levels is by means of an internal ladder.

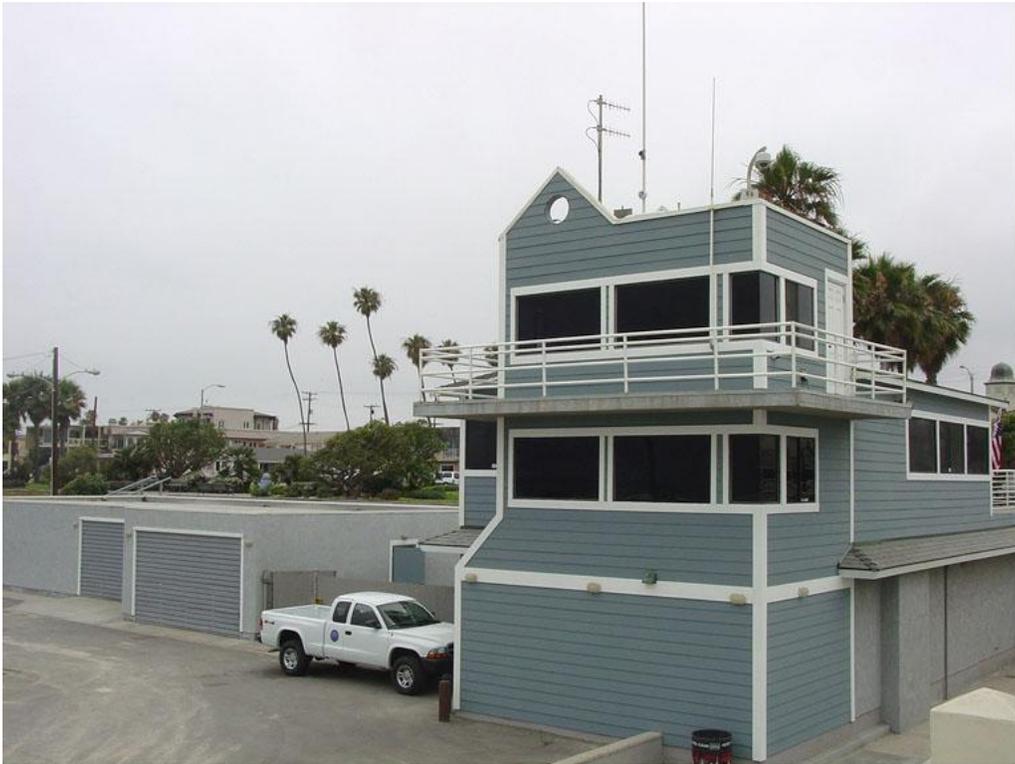
### SEAL BEACH PIER – LIFE GUARD HEADQUARTERS

888 Ocean Avenue  
Assessment date: October 21, 2010

The Seal Beach Life Guard Headquarters facility has gone through several major modifications over the years. The original site was constructed in the 1930's as part of the Seal Beach Pier, and has grown over the years with buildings approximately in the same location as originally intended. A garage building was originally built some time in the late 60's early 70' as a single level at beach level, one story below street level. The building abutted a retaining wall (still present today). Later in the 1970's the garage was then converted into a Life Guard Headquarters by closing off the large vehicle garage doors and adding approximately 200 square feet to the south. This addition added two small offices and a storage room. In 1983, a three story tower was added over the first addition. In 1995, the Police Safety Building was added over the original garage abutting the Life Guard's tower addition.

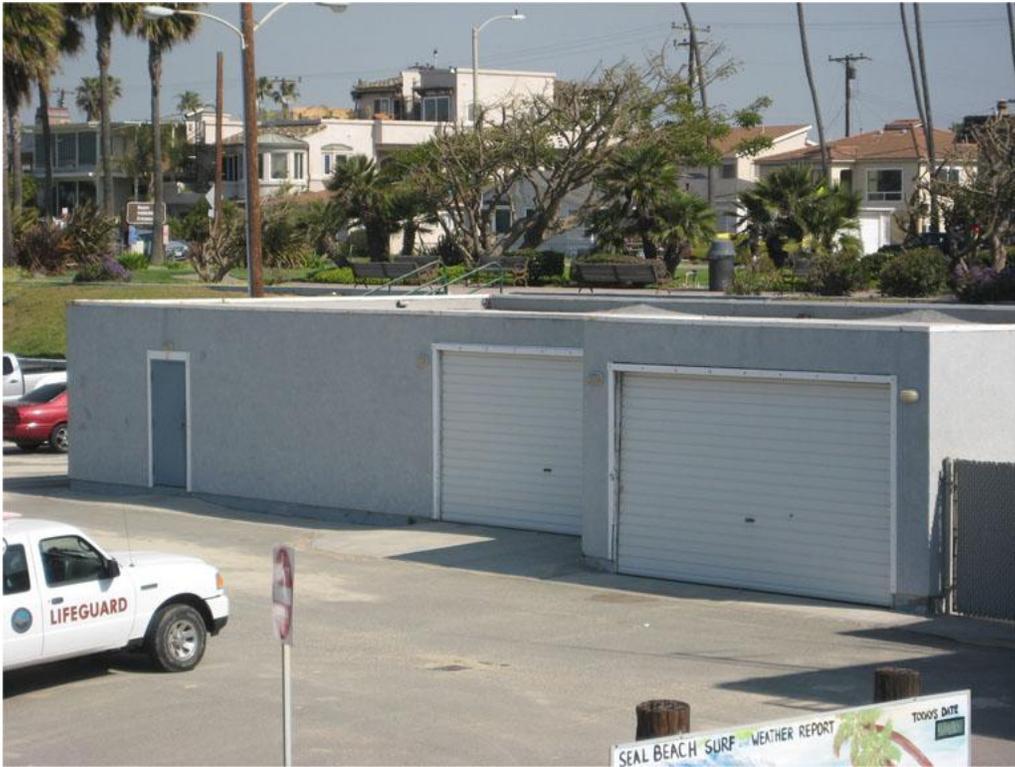
## Building #10F

### SEAL BEACH PIER – LIFE GUARD GARAGE

888 Ocean Avenue  
Assessment date: October 21, 2010

The Seal Beach Life Guard Garage was constructed in 1980. The Building is located in the north east corner of the public beach parking lot adjacent to the Life Guard Headquarters and is accessed from the parking lot.

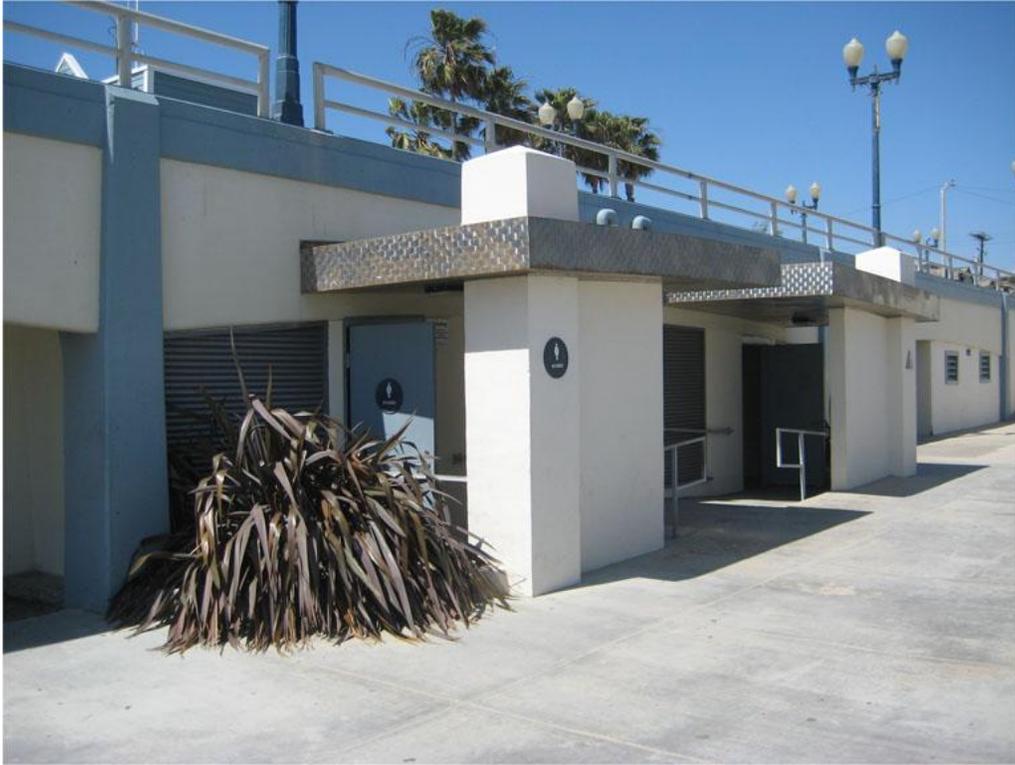
## Building #10H

### SEAL BEACH PIER - RESTROOMS

900 Ocean Avenue  
Assessment date: October 21, 2010

The Seal Beach Pier was originally built in 1938. It was later re-built in 1983. In 1992 and again in 1994 fire damaged the Pier. Repairs were made as a result of the fire and then additional repairs were made in 2003/2004.

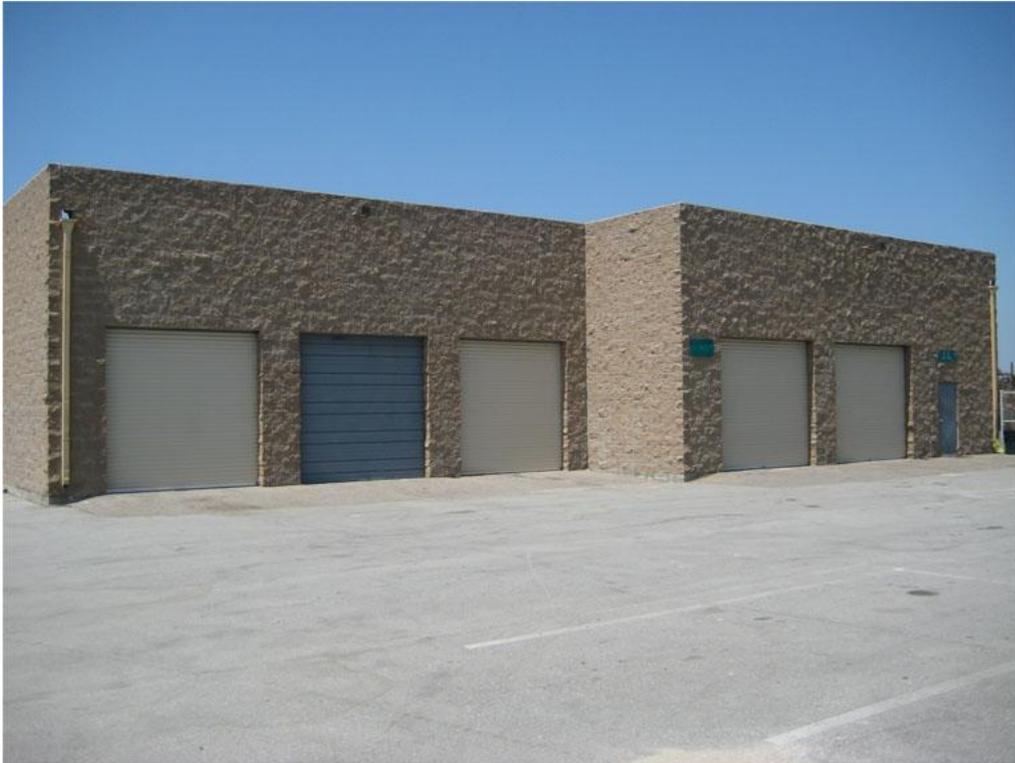
## Building #13

# BEACH FACILITIES – MAINTENANCE BUILDING (GARAGE)

1st Street Parking Lot  
Assessment date: October 7, 2010

The Beach Facilities Maintenance Building was originally constructed in 1976. The Building is located in the north west corner of the 1<sup>st</sup> Street beach parking lot

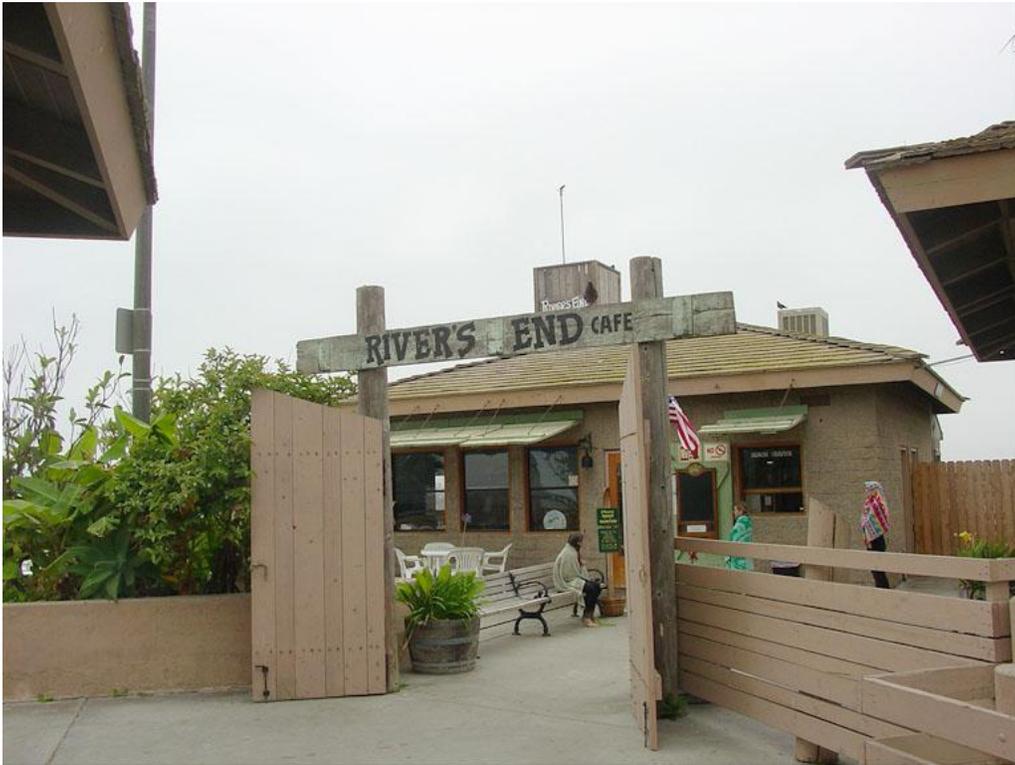
## Building #13A

### BEACH FACILITIES – RESTAURANT

15 1st Street Parking  
Assessment date: October 7, 2010

The Beach Facilities Restaurant Building was originally constructed in 1976 as a concessions facility along with the restrooms and dressing rooms. The Building is located in a small complex at the south end of the 1<sup>st</sup> Street beach parking lot. The restaurant building along with the dressing room building is leased to a restaurant service provider (Rivers End Café). It is the teams understanding that the lease with the City was renewed in 2010 for another 10-year period. The terms of the lease require the lessee, Rivers End Café, to provide all taxes, insurance and maintenance expenses that arise from the use of the City owned property.
