**Report Presented to the City of Seal Beach**

**Facility Condition Assessment Study  
and Strategic Planning Project**

**Facility Condition Assessment  
Final Draft Report**

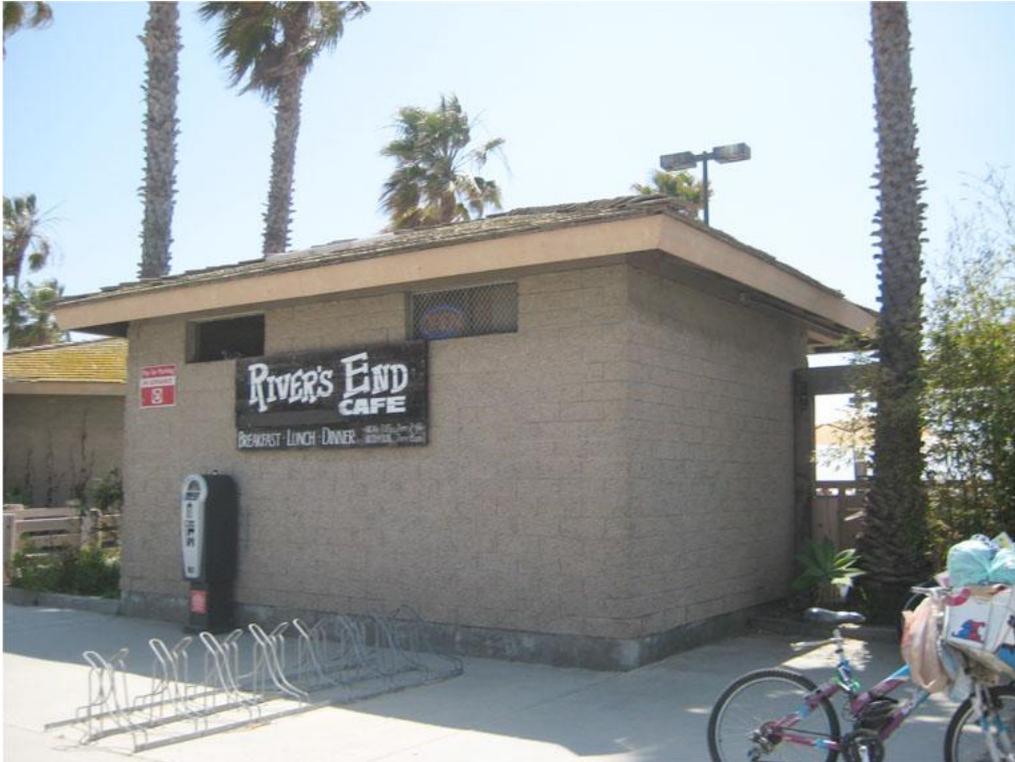
## Building #13B

### BEACH FACILITIES – STORAGE BUILDING (DRESSING ROOMS)

1st Street Parking Lot  
Assessment date: October 7, 2

The Beach Facilities Storage Building was originally constructed in 1976 as open public dressing rooms. The Building is located in a small complex at the south end of the 1<sup>st</sup> Street beach parking lot which contains public restrooms and a restaurant facility. This storage room along with the restaurant facility is leased to a restaurant service provider (Rivers End Café). It is the Teams understanding that the lease with the City was renewed in 2010 for another 10-year period. The terms of the lease require the lessee, Rivers End Café, to provide all taxes, insurance and maintenance expenses that arise from the use of the City owned property.

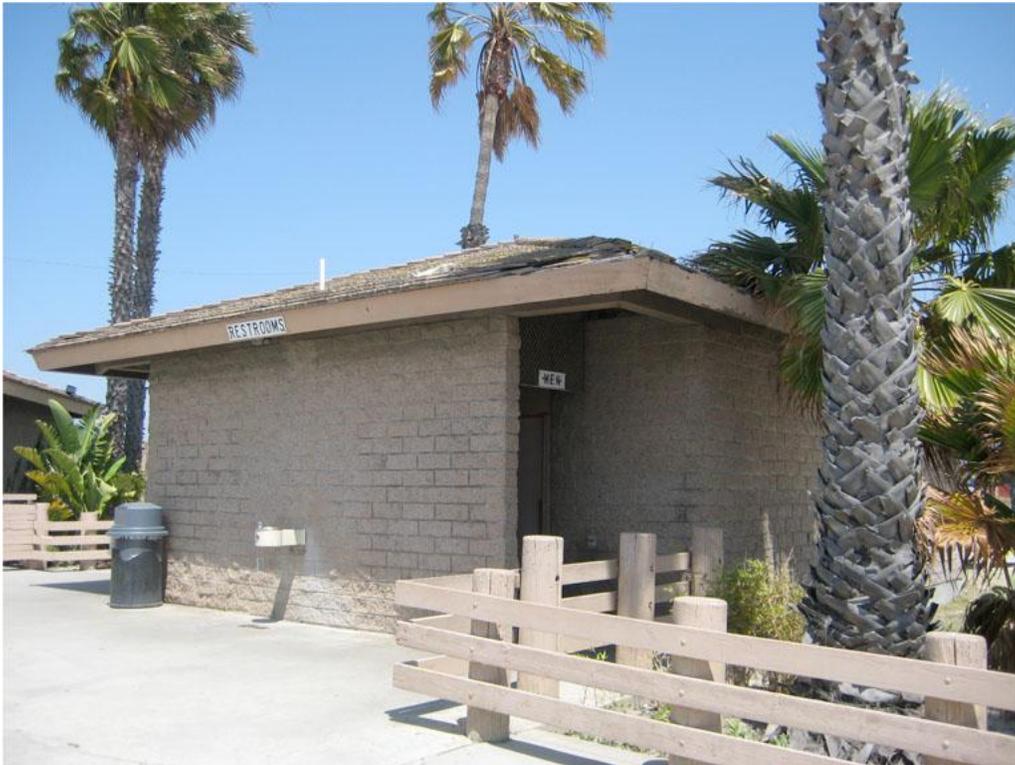
## Building #13C

### BEACH FACILITIES – RESTROOM BUILDING

1st Street Parking Lot  
Assessment date: October 7, 2010

The Beach Facilities Restroom was originally constructed in 1976. The Building is located in a small complex at the south end of the 1<sup>st</sup> Street beach parking lot which contains the these public restrooms, a storage room (former changing rooms – now part of the restaurant facility) and a restaurant facility. The restaurant facility and the storage room are leased to a restaurant service provider who is responsible for the improvements and maintenance of these two buildings.

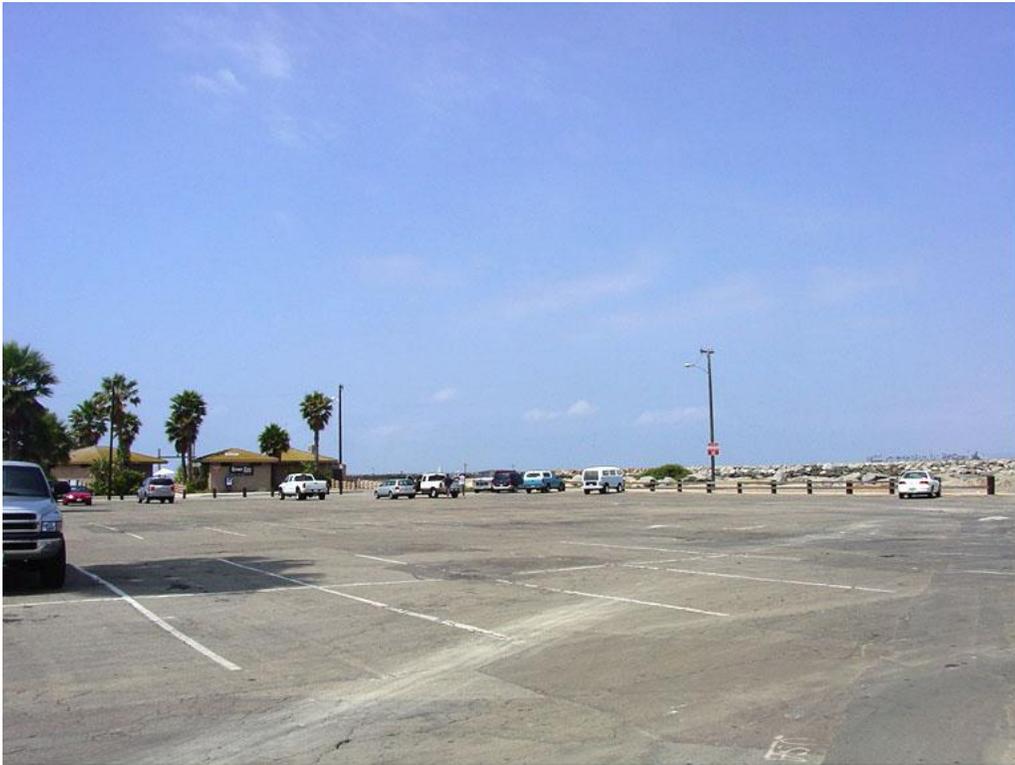
## Building #13D

### BEACH FACILITIES – PARKING LOT

1st Street Parking Lot  
Assessment date: October 7, 2010

The general condition of the Parking Lot paving is marginal to poor and in need of repair. The asphalt was cracking and damaged in many areas. The parking stall stripping was faded. The current configuration of the paving areas does not appear to follow current best practices for waste / storm water management. The entire parking lot appears to drain onto the beach. Drainage was also poorly designed and results in multiple ponding issues some of which were several inches deep. This parking area becomes submerged in extreme high tides.

The existing Parking Lot is in generally poor condition overall. A survey and analysis needs to be done to determine the extent of re-contouring that may be required to provide proper drainage. Drainage must be analyzed for compliance with storm water management requirements. The lighting needs to be analyzed to provide proper lighting. The need for entry controls needs to be verified and implemented as required. Re-stripping needs to be performed and the proposed improvements made for disabled access parking and path of travel to adjacent facilities.

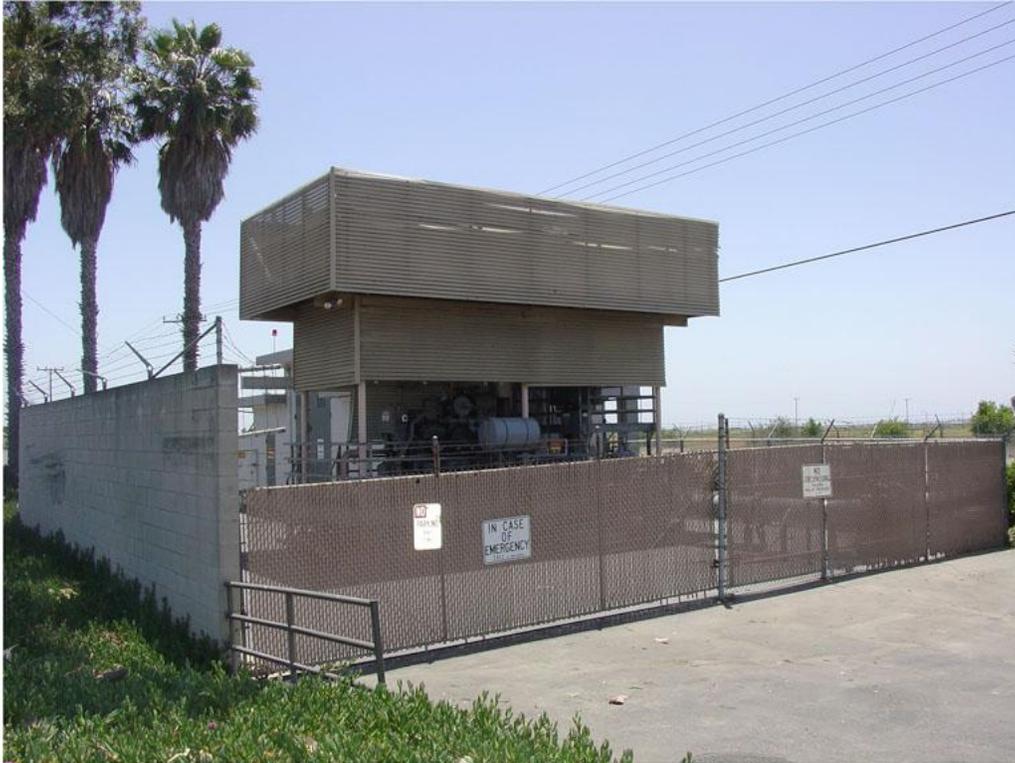
## Building #16

### BOLSA CHICA WELL & PUMP HOUSE

3333 Bolsa Chica Road  
Assessment date: September 30, 2010

The Bolsa Chica Well and Pump complex was originally constructed in 1977. The complex includes a main pump control building with a small wood frame exterior storage shed addition and a separate exterior exposed pump motor with a screened and covered enclosure assembly.

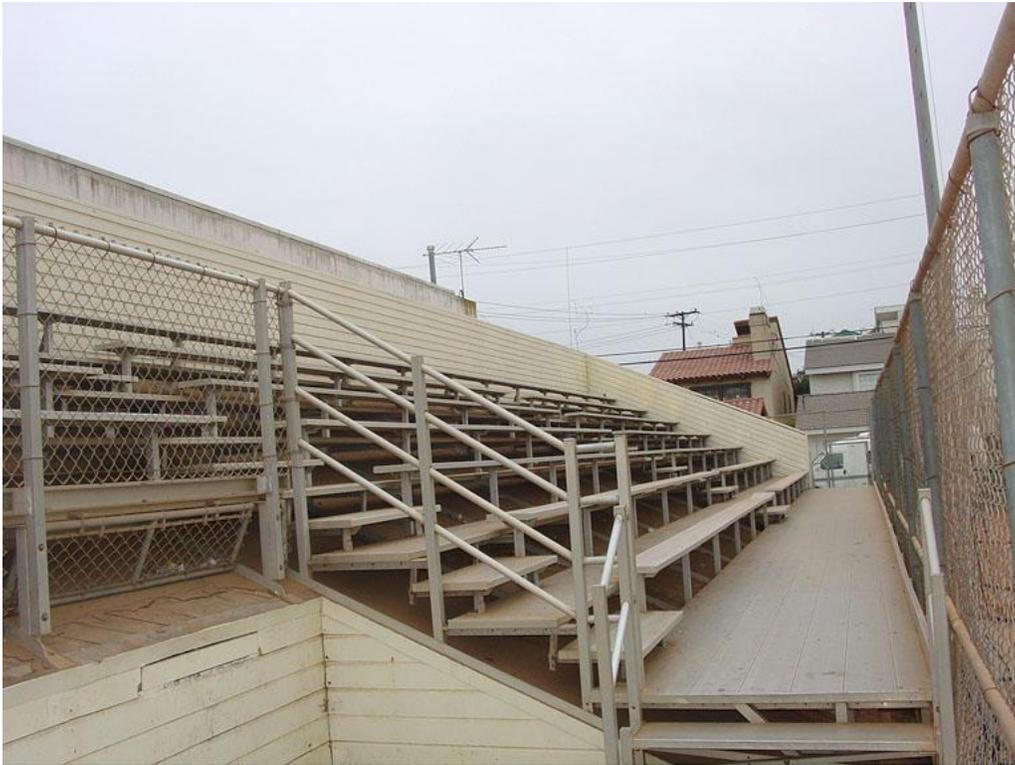
## Building #29B

### ZOETER BLEACHERS

Landing Avenue at 11<sup>th</sup> Street  
Assessment date: August 19, 2010

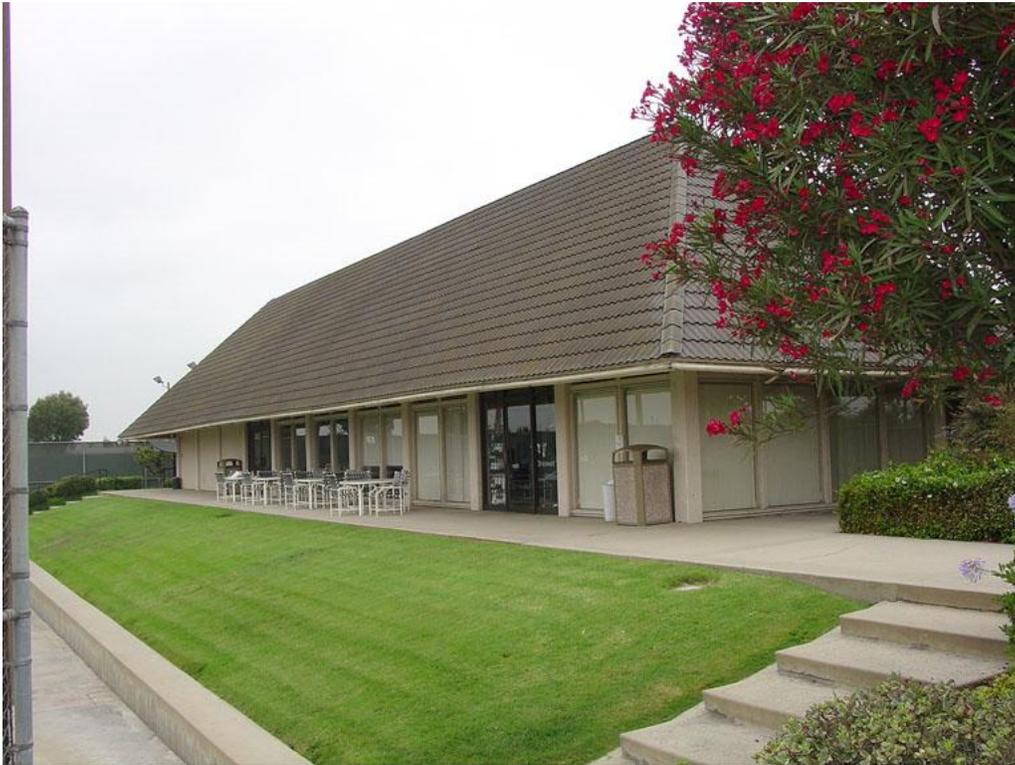
**Building #37**

**TENNIS CENTER CLUBHOUSE**

**3900 Lampson**

**Assessment date: September 23, 2010**

The general physical appearance of the Club House is marginal. The building is a concrete post and wood beam structure with wood siding that has weathered poorly and shows numerous signs of water damage, wood rot and insect damage. Paint has been added over the years to cover-up the wear but the underlying wood timber members and siding require more significant attention. The exterior siding has exceeded its expected service life. The wood trim members at the fascia, the open trellis members, wood windows and the wood door/window frames all show significant deterioration from water and insects. The cantilevered patio cover structural members show signs of deterioration and distortion. The replacement aluminum doors are in marginal condition with some issues due mainly to the condition of the surrounding wood frames.

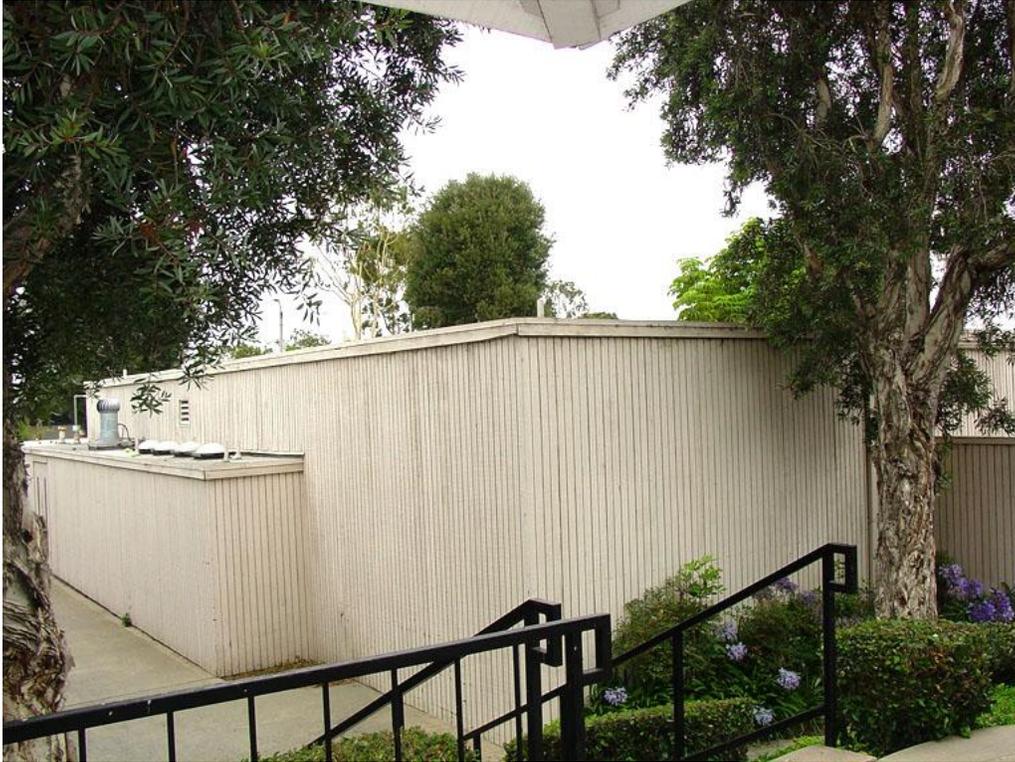
**Building #37A**

**TENNIS CENTER  
LOCKERS / SHOWERS / RESTROOMS**

**3900 Lampson  
Assessment date: September 23, 2010**

The Locker/Shower/Restroom building is housed in a separate single story structure that was constructed as part of the original 1970's project. The facility is not staffed and is open to members of the Tennis Club only. The building is approximately 3,200 square feet in size. The facility has four basic components including separate locker, shower and restroom facilities for men and women separated by an open atrium court with screen divider. The design of the facility is very unique, open and airy. The men's facility contains a non-operational spa and sauna while the women's facility has had the original spa filled in with concrete. A storage room was added to the women's locker area. The west side of the facility contains storage rooms and mechanical equipment rooms including the non-operational spa equipment.

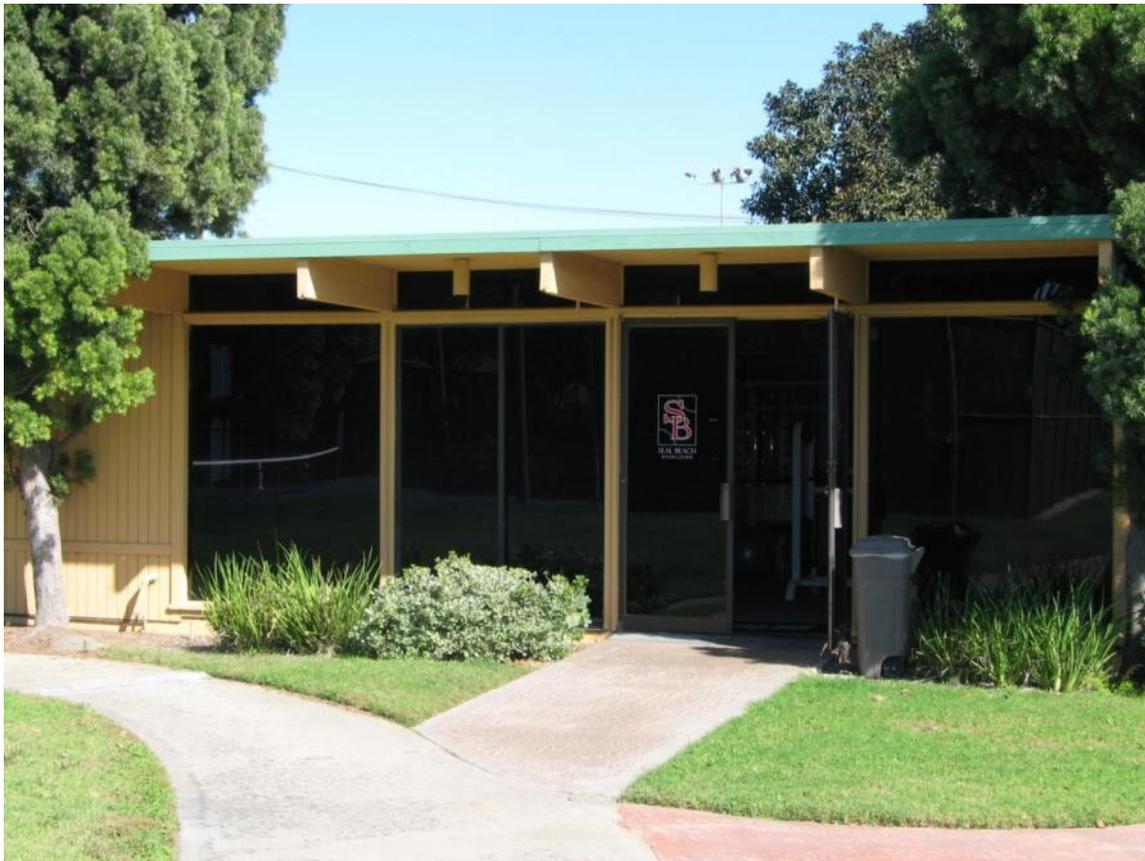
The Fitness Center is housed in a separate single story structure that was constructed as part of the original 1970's project. The center is approximately 1,000 square feet in size and consists of a single work out room with various types of fitness equipment. Over half of the exterior walls consist of floor to ceiling windows with sliding doors to the exterior and a double entry door facing west with a protective overhang.

The general exterior physical appearance of the Fitness Center is poor. The building is simply a post and beam wood structure with wood siding that has weathered poorly and shows numerous signs of water damage, wood rot and insect damage. Numerous coats of paint have been added over the years to cover-up the wear but the underlying members and siding require more significant attention. It is apparent that some repairs have been made over the years but as stated in the 2004 Assessment Report, the exterior siding has exceeded its expected service life. This is also the case for the wood trim members at the fascia, doors/windows and the door/window frames. Likewise, the cantilevered entry cover structural members show signs of deterioration and the roof / ceiling sheathing is sagging noticeably.

The roof and flashings are in very poor condition and appear to have long outlived their service life and should be replaced. The roof design is essentially a flat roof. Water was contained by the perimeter flashing and diverted to small scuppers the poured over the edge and designated locations. Due to the middle of the roof sagging, the water began to pond in the center of the roof before filling up enough to drain over the edge. To remedy this, a drain was added at the center of the roof. To correct all these issues it is recommended that the entire roof structure including structural members be replaced and a new roof be installed with proper slope and drainage.

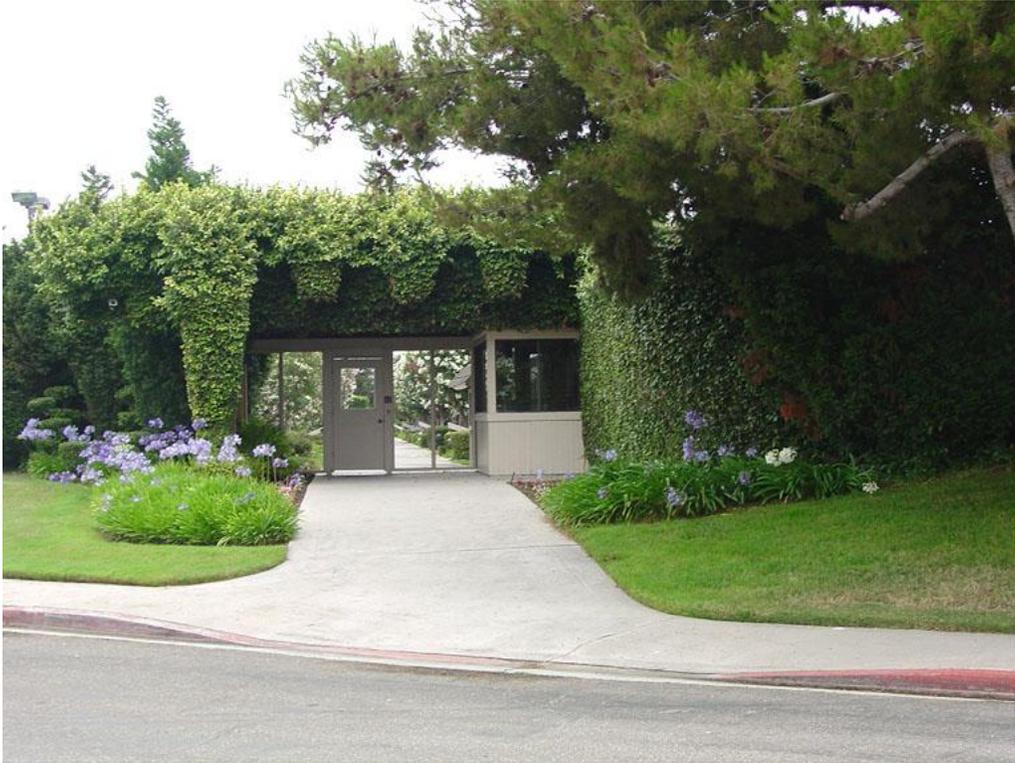
## Building #37C

### TENNIS CENTER GATE / SITE

The gated entry and guard house of the City of Seal Beach Tennis Center functions as the primary access point to the secured tennis facility. The Entry Portal (gate) consists of a landscaped wood trellis structure with a wood and open metal gate / screen fence attached to a small Guardhouse. The original function of this arrangement was for guest to arrive at the facility and be screened and assigned courts by staff personal working from the Guardhouse. This staff function has long since been deleted and guests now check in at the Club House. The Guardhouse currently serves no function. The main gate door remains unlocked during operational hours allowing anyone to enter reducing the level of security and requiring the Club House staff to monitor the courts to make sure it is being used by members only.

The general exterior physical appearance of the Entry Portal is poor with the exception of the vegetation. The surrounding security walls and the exposed wood trellis structure is completely covered with planting. While this is aesthetically appealing, the condition of the underlying wood structure is visibly unknown.

The gate structure is made of wood frames for a wood gate and metal security mesh. The wood is showing signs of wood rot and general abuse over the years. Graphics are placed over the metal mesh creating a poor aesthetic.

The Guardhouse exterior is in marginal condition. Given the fact that it has not been used in many years it has been left to weather. The wood siding and trim are showing signs of wood rot, water damage and damage from the overgrown planting.

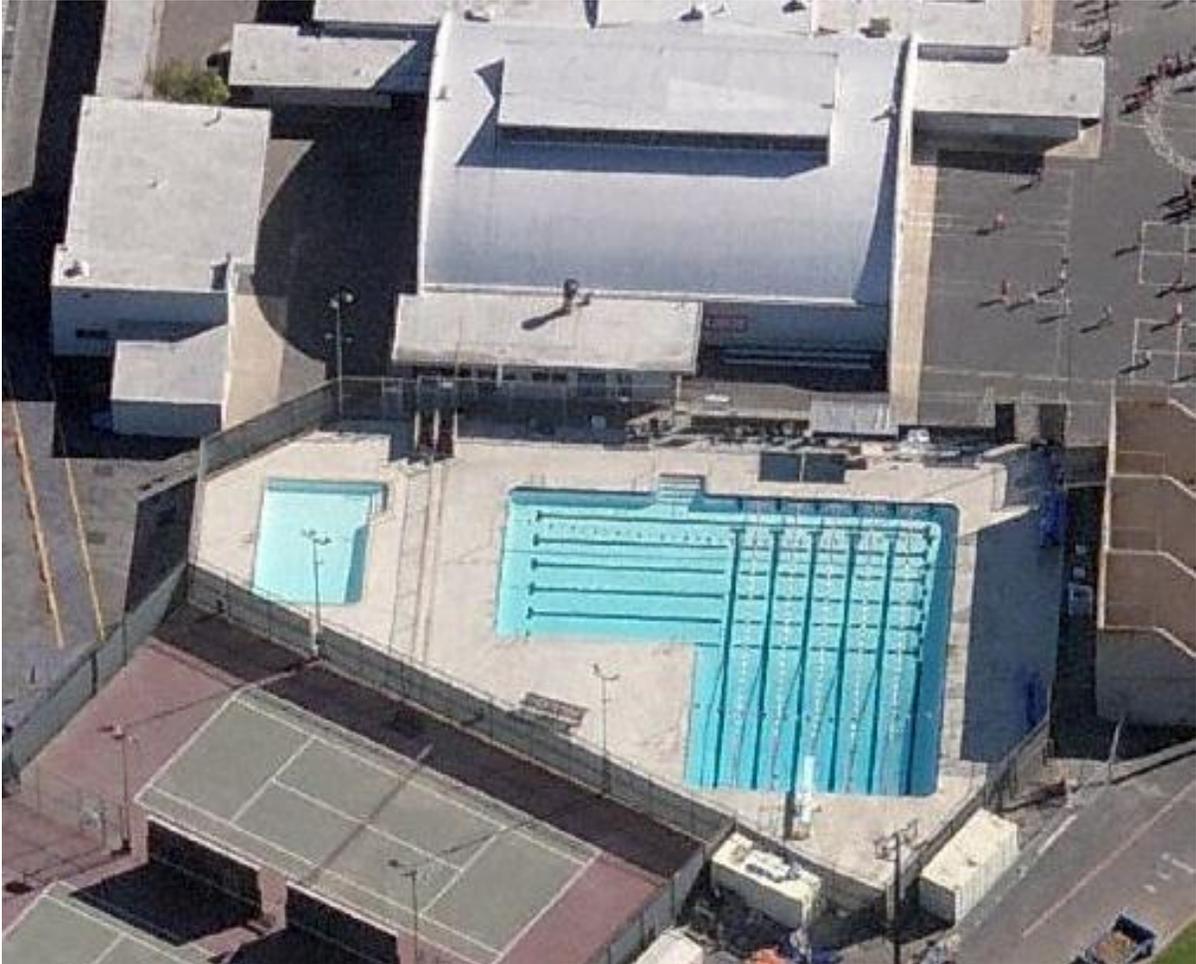
## Building #38

### McGAUGH POOL FACILITY

The McGaugh Pool Facility (Seal Beach Aquatic Facility / Seal Beach Community Pool) was originally constructed around 1964 / 1965 as an addition to the adjacent McGaugh School facility. The facility includes a fenced deck area with an L-shaped 25-yard x 25 meter competition/lap pool and a 20-foot by 30-foot shallow children's pool with associated outdoor showers and drinking fountains. A portable changing room facility with two compartments is located within the fenced area of the pool deck.

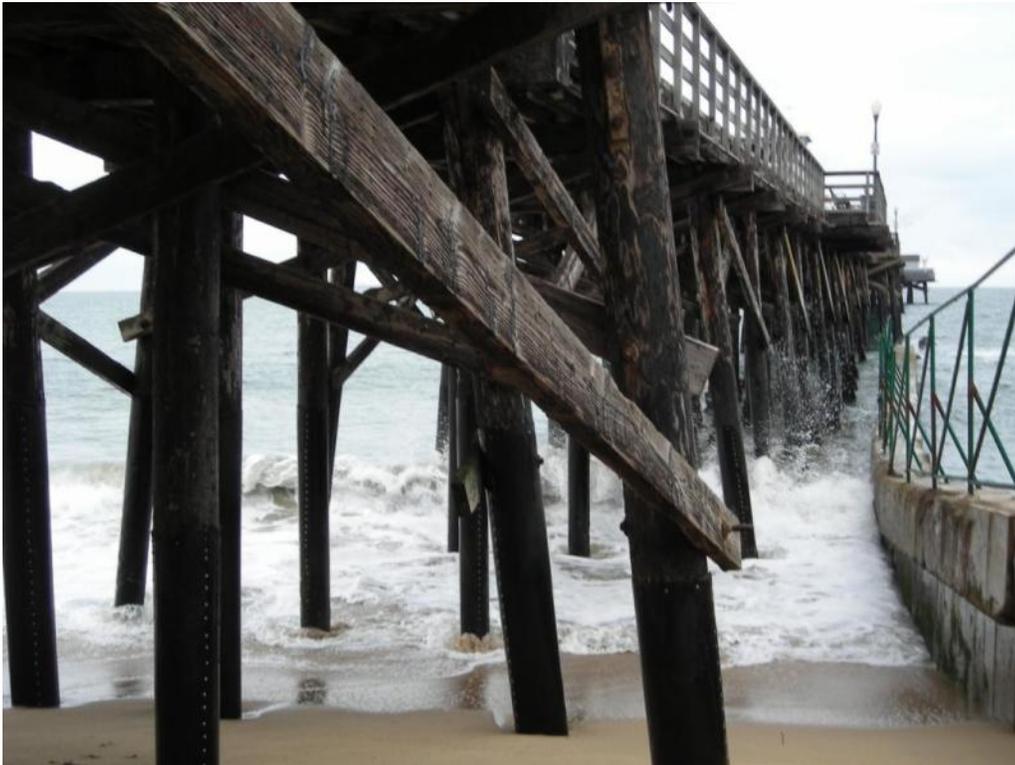
## Building #39

### SEAL BEACH PIER – UTILITIES

900 Ocean Avenue  
Assessment date: October 21, 2010
